# Appendix B

**LATERAL POINT REPAIR #1**

**PACP Sewer Report**

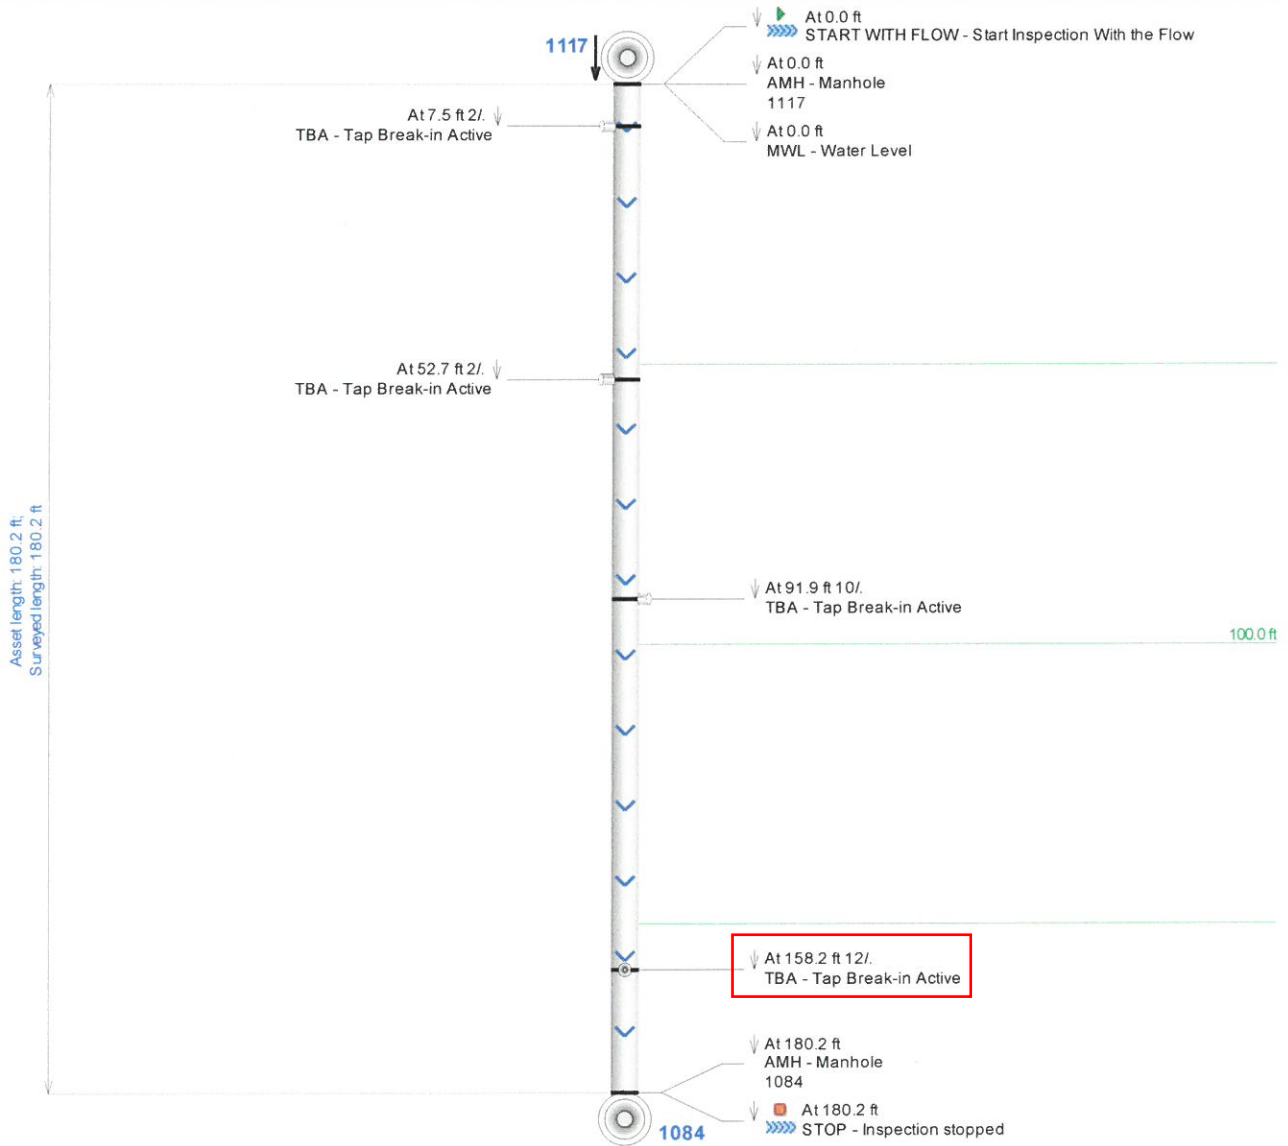
**LATERAL POINT REPAIR #1**

Distance (Feet) (Meters)	Video Ref.	Group/ Descriptor	Modifier/ Severity	S/M/L	Value		Joint	Circumferential Location	Image Ref.	Remarks
					Inches (mm) 1st	2nd				
0.0	1	AMH								1117
0.0	13	MWL				5				
7.5	62	TBA			6		2			
52.7	157	TBA			6		2			
91.9	230	TBA			6		10			
158.2	329	TBA			6		12			
180.2	399	AMH								1084

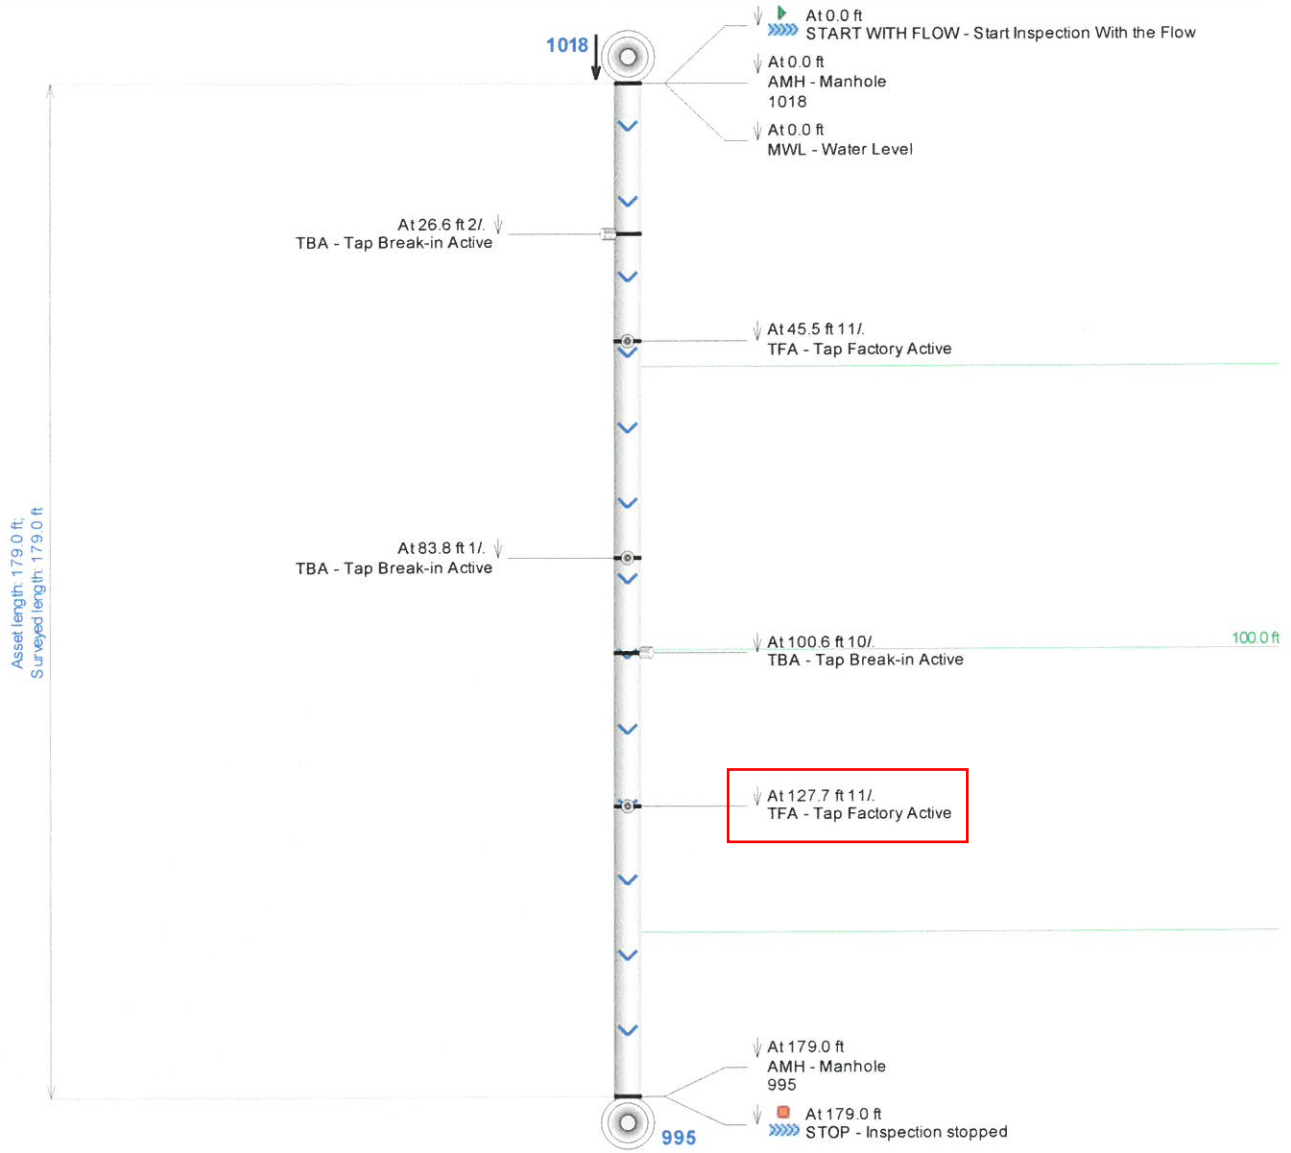
**LATERAL POINT REPAIR #2**

Distance (Feet) (Meters)	Video Ref.	Group/ Descriptor	Modifier/ Severity	S/M/L		Value		Joint	Circumferential Location	Image Ref.	Remarks
				1st	2nd	Inches (mm)	%				
0.0	1	AMH									1018
0.0	22	MWL					5				
26.6	135	TBA			6			2			
45.5	180	TFA			6			11			
83.8	282	TBA			6			1			
100.6	319	TBA			6			10			
127.7	386	TFA			6			11			
179.0	551	AMH									995

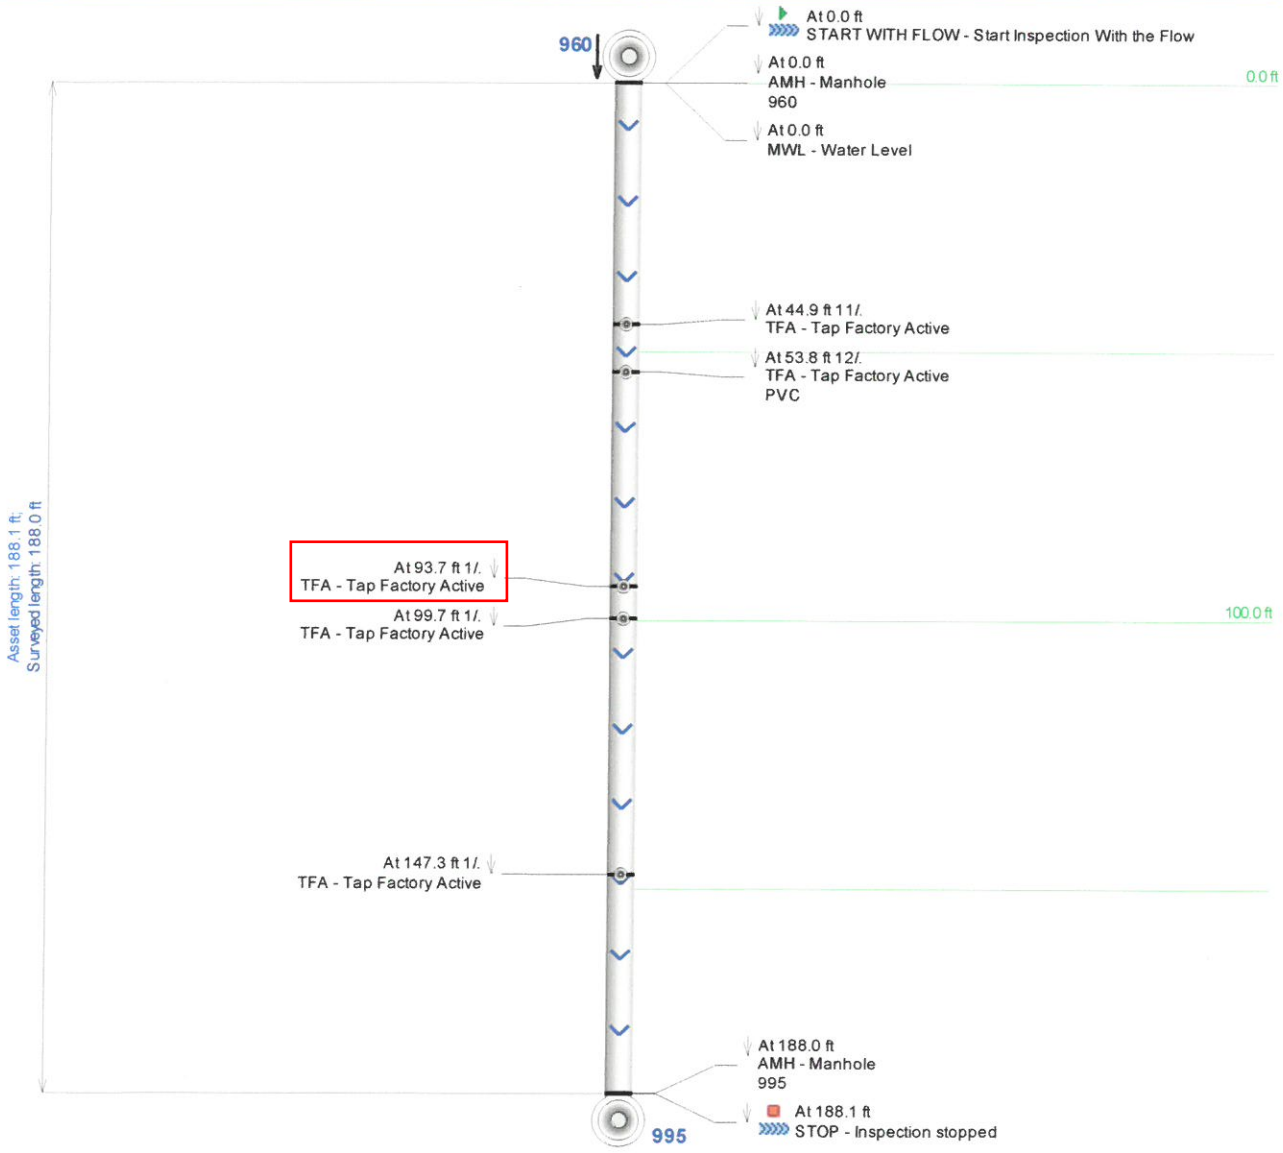
**LATERAL POINT REPAIR #3**

Distance (Feet) (Meters)	Video Ref.	Group/ Descriptor	Modifier/ Severity	Continuous Defect S/M/L	Value		Joint	Circumferential Location	Image Ref.	Remarks
					Inches (mm)	%				
					1st	2nd	AV/From	to		
0.0	1	AMH								960
0.0	10	MWL				5				
44.9	104	TFA			6		11			
53.8	170	TFA			6		12			PVC
93.7	244	TFA			6		1			
99.7	276	TFA			6		1			
147.3	360	TFA			6		1			
188.0	481	AMH								995

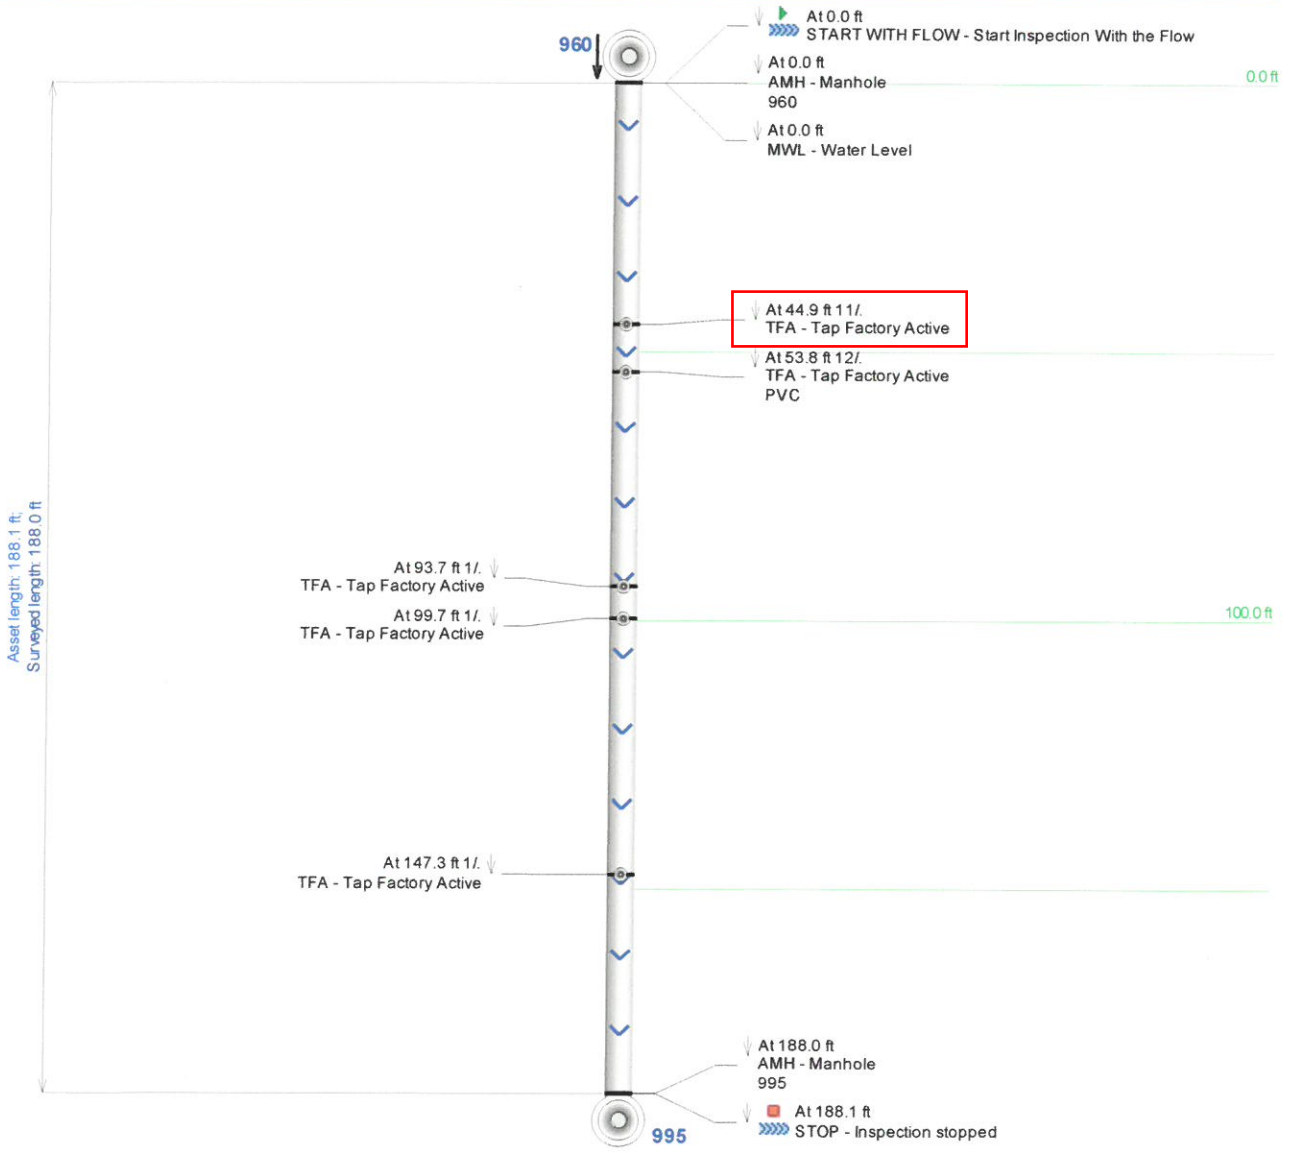
**LATERAL POINT REPAIR #4**

Distance (Feet) (Meters)	Video Ref.	Group/ Descriptor	Modifier/ Severity	Continuous Defect S/M/L	Value		Joint	Circumferential Location	Image Ref.	Remarks
					Inches	2nd				
					1st		AV/From	to		
0.0	1	AMH								960
0.0	10	MWL				5				
44.9	104	TFA			6		11			
53.8	170	TFA			6		12			PVC
93.7	244	TFA			6		1			
99.7	276	TFA			6		1			
147.3	360	TFA			6		1			
188.0	481	AMH								995

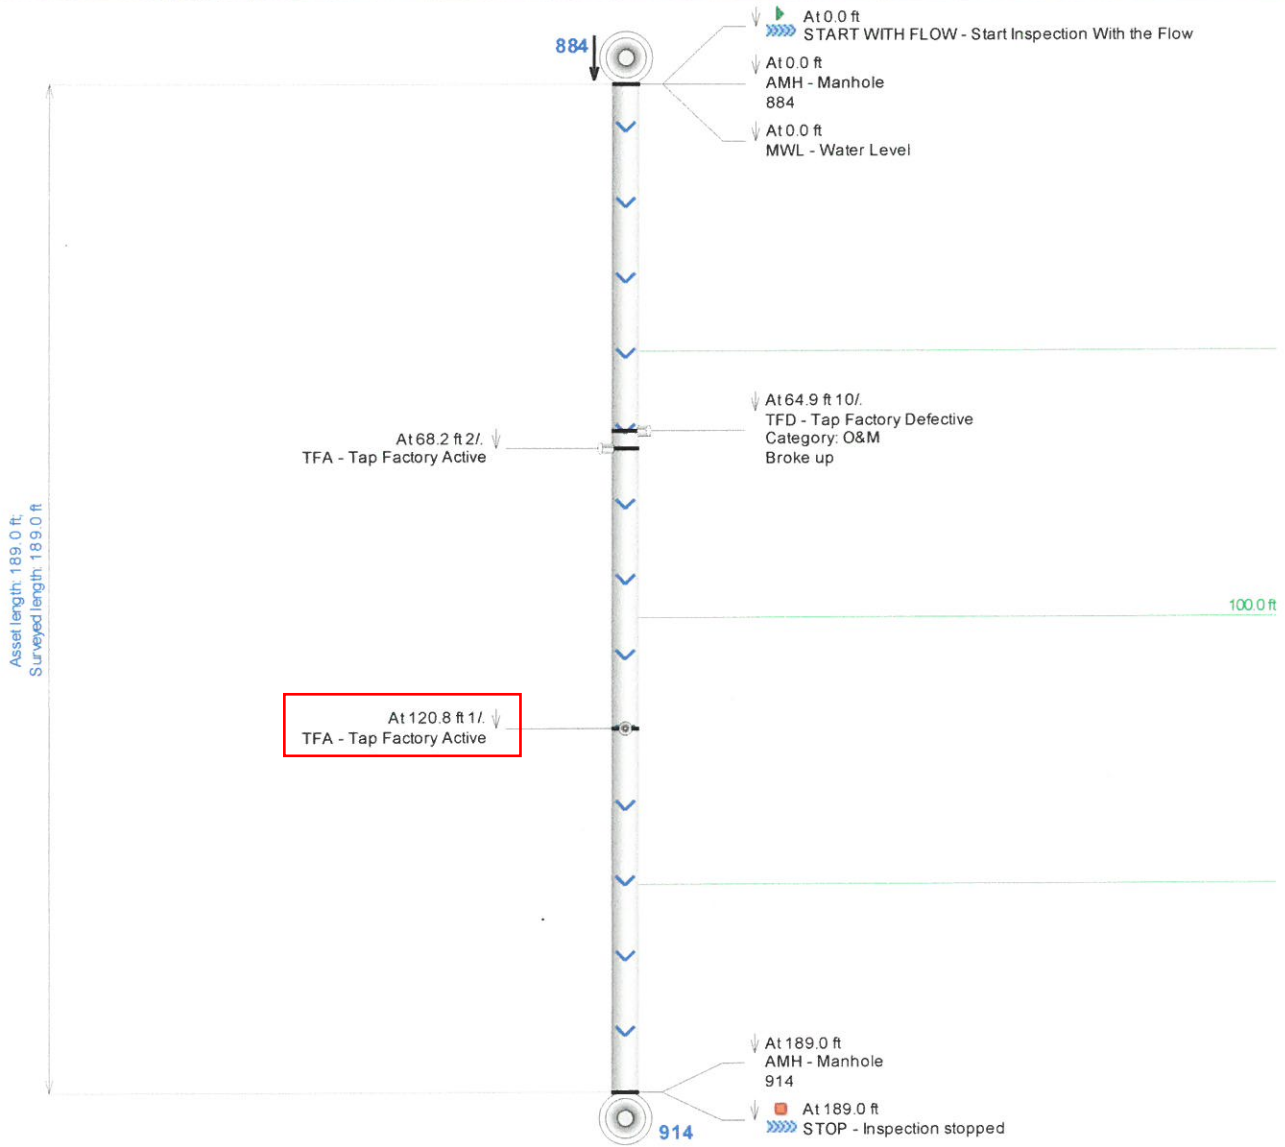
**LATERAL POINT REPAIR #5**

Distance (Feet) (Meters)	Video Ref.	Group/ Descriptor	Modifier/ Severity	S/M/L	Value		%	Joint	Circumferential Location	Image Ref.	Remarks
					Inches (mm) 1st	2nd					
0.0	6	AMH									884
0.0	15	MWL					5				
64.9	106	TFD			6			10			Broke up
68.2	152	TFA			6			2			
120.8	229	TFA			6			1			
189.0	332	AMH									914

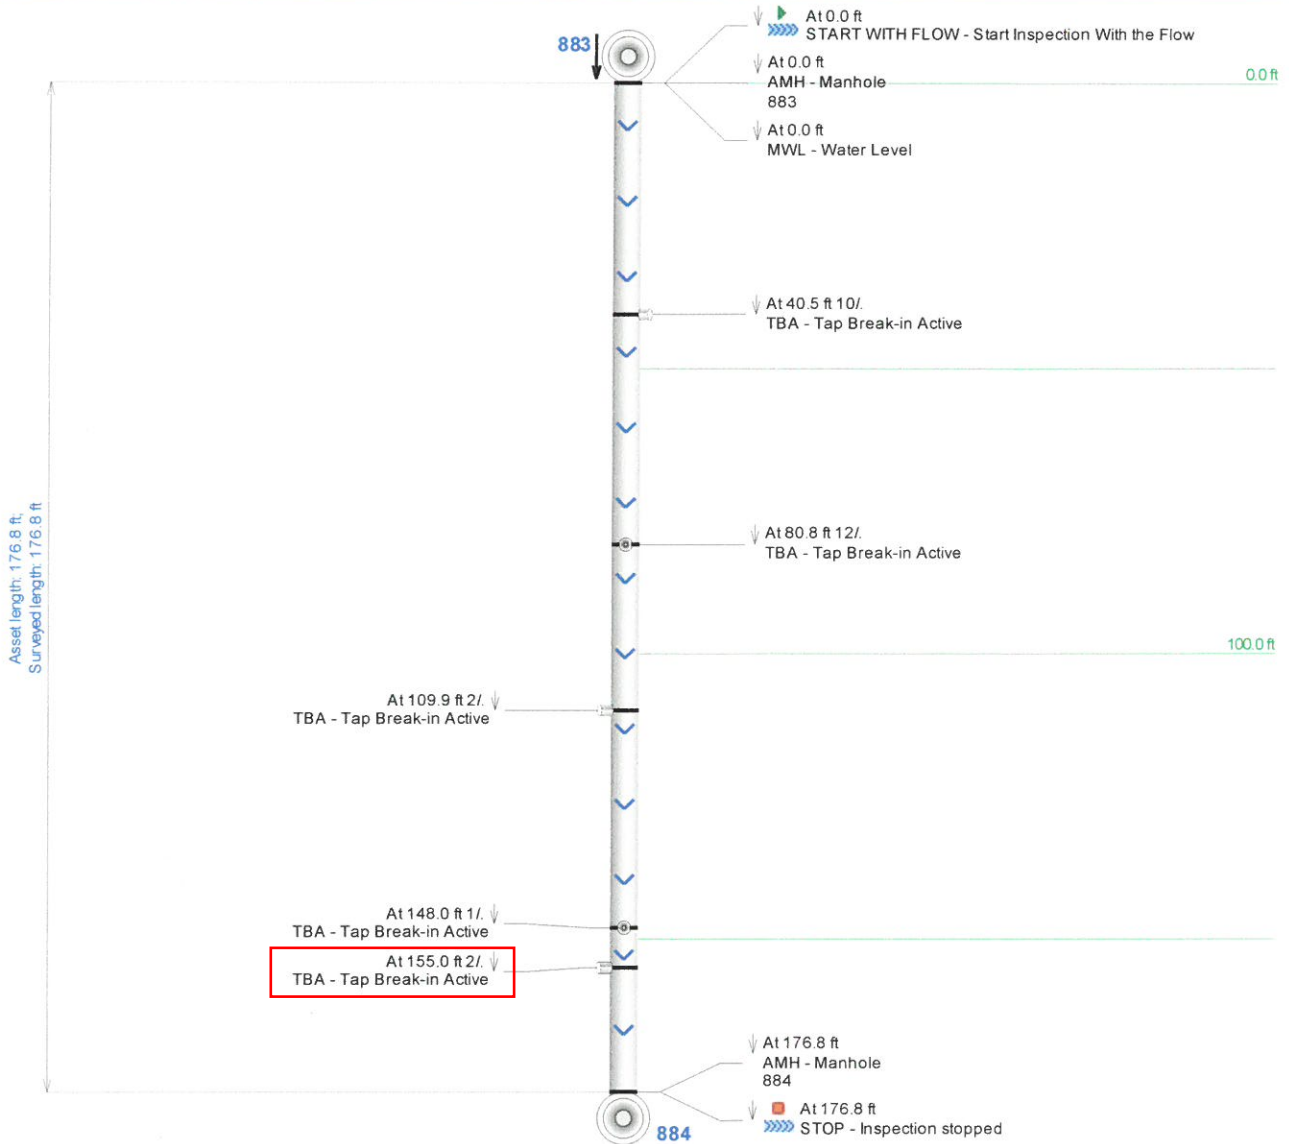
**LATERAL POINT REPAIR #6**

Distance (Feet) (Meters)	Video Ref.	Group/ Descriptor	Modifier/ Severity	S/M/L	Value Inches (mm)	%	Joint	Circumferential Location	Image Ref.	Remarks
					1st	2nd		At/From	to	
0.0	13	AMH								883
0.0	42	MWL				5				
40.5	248	TBA			6			10		
80.8	431	TBA			6			12		
109.9	624	TBA			6			2		
148.0	787	TBA			6			1		
155.0	949	TBA			6			2		
176.8	1105	AMH								884

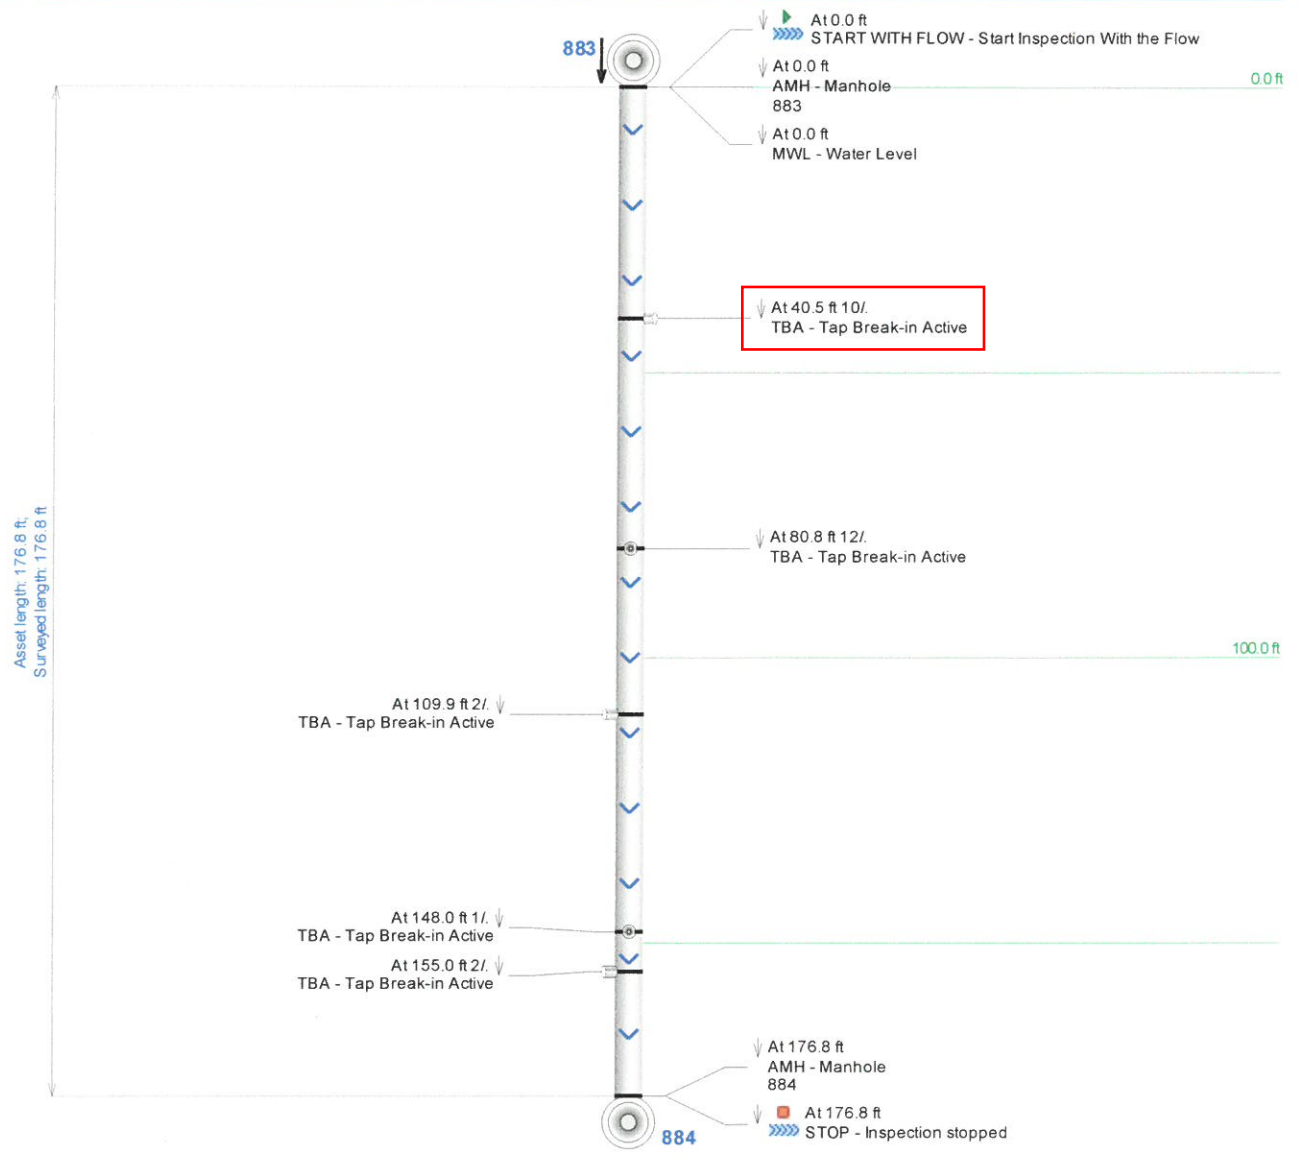
**LATERAL POINT REPAIR #7**

Distance (Feet) (Meters)	Video Ref.	Group/ Descriptor	Modifier/ Severity	S/M/L	Value Inches (mm)	%	Joint	Circumferential Location	Image Ref.	Remarks
					1st	2nd		At/From	to	
0.0	13	AMH								883
0.0	42	MWL				5				
40.5	248	TBA			6			10		
80.8	431	TBA			6			12		
109.9	624	TBA			6			2		
148.0	787	TBA			6			1		
155.0	949	TBA			6			2		
176.8	1105	AMH								884

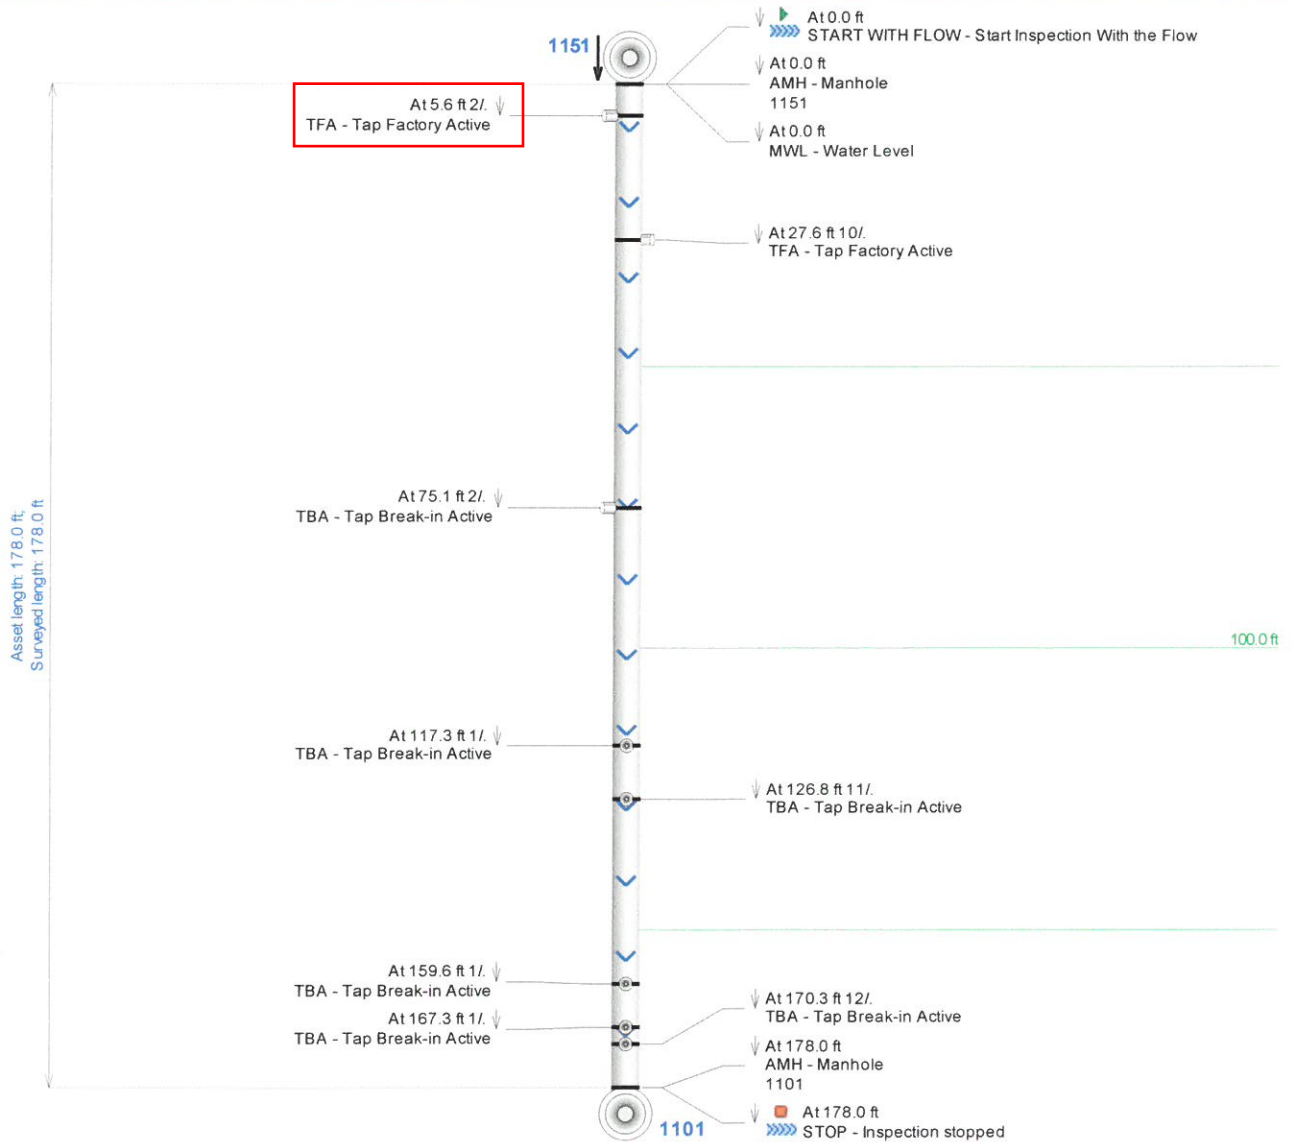
**LATERAL POINT REPAIR #8**

Distance (Feet) (Meters)	Video Ref.	Group/ Descriptor	Modifier/ Severity	S/M/L	Value		Joint	Circumferential Location	Image Ref.	Remarks
					Inches (mm) 1st	2nd				
0.0	1	AMH								1151
0.0	13	MWL				5				
5.6	45	TFA			6		2			
27.6	101	TFA			6		10			
75.1	185	TBA			6		2			
117.3	263	TBA			6		1			
126.8	304	TBA			6		11			
159.6	391	TBA			6		1			
167.3	424	TBA			6		1

Distance (Feet) (Meters)	Video Ref.	Group/ Descriptor	Modifier/ Severity	Continuous Defect	S/W/L	Value Inches (mm)		Joint	Circumferential Location AV/From      to	Image Ref.	Remarks
						1st	2nd				
170.3	450	TBA				6			12		
178.0	479	AMH									1101

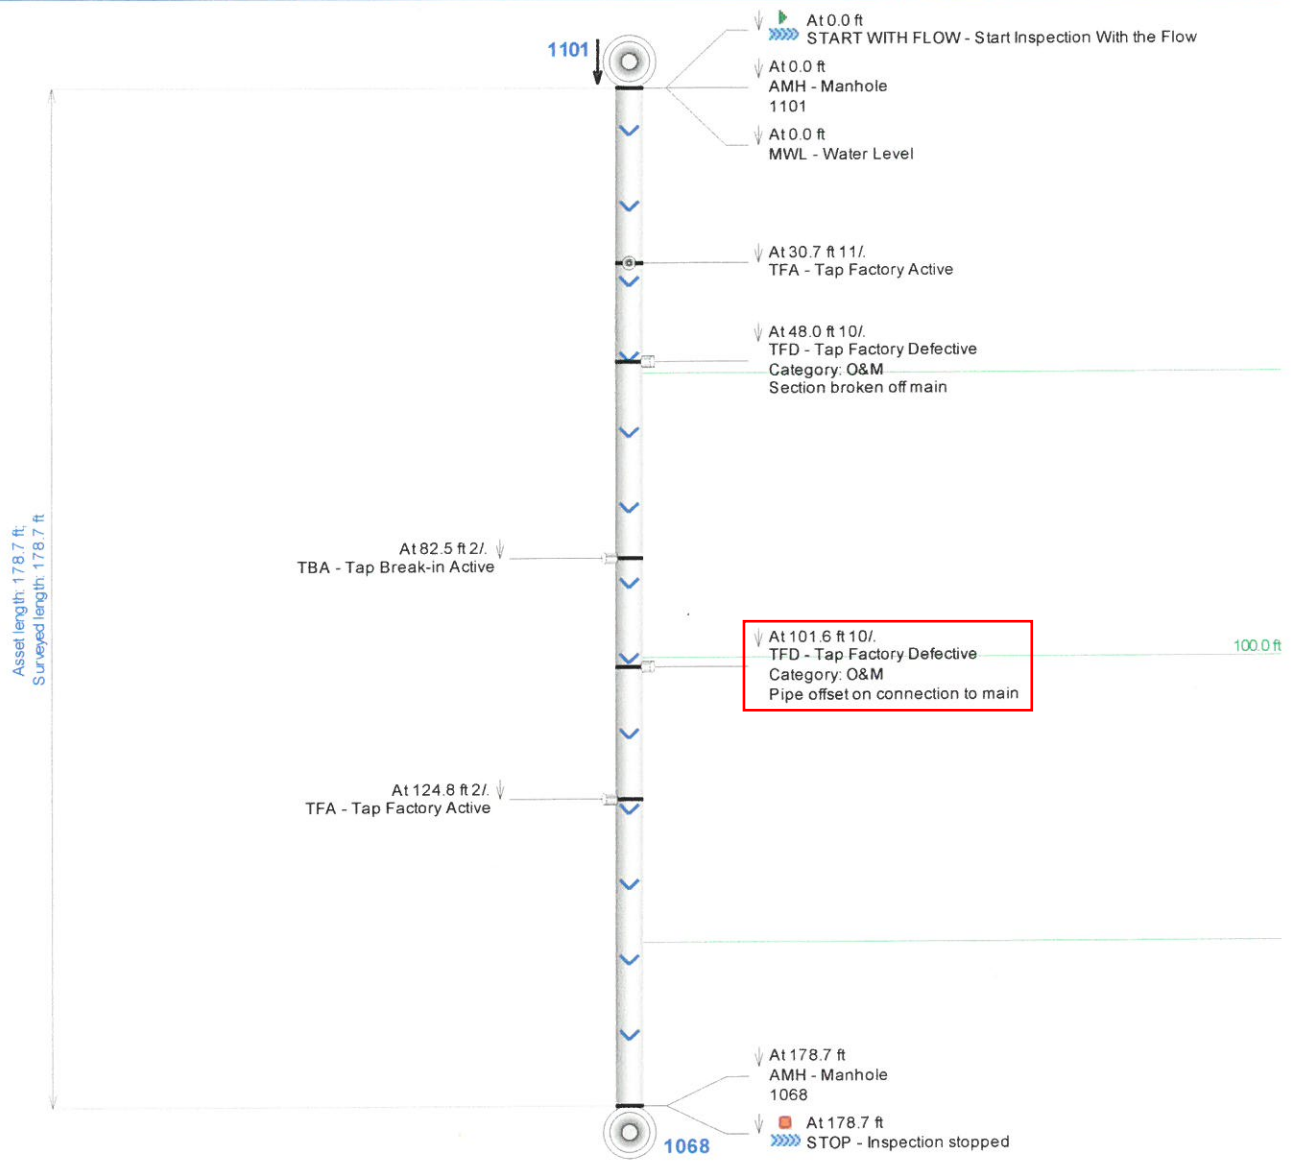
**LATERAL POINT REPAIR #9**

Distance (Feet) (Meters)	Video Ref.	Group/ Descriptor	Modifier/ Severity	Continuous Defect S/M/L	Value Inches (mm)		Joint %	Circumferential Location At/From	to	Image Ref.	Remarks
					1st	2nd					
0.0	6	AMH									1101
0.0	18	MWL					5				
30.7	72	TFA			6			11			
48.0	117	TFD			6			10			Section broken off main
82.5	205	TBA			6			2			
101.6	264	TFD			6			10			Pipe offset on connection to main
124.8	376	TFA			6			2			
178.7	463	AMH									1068

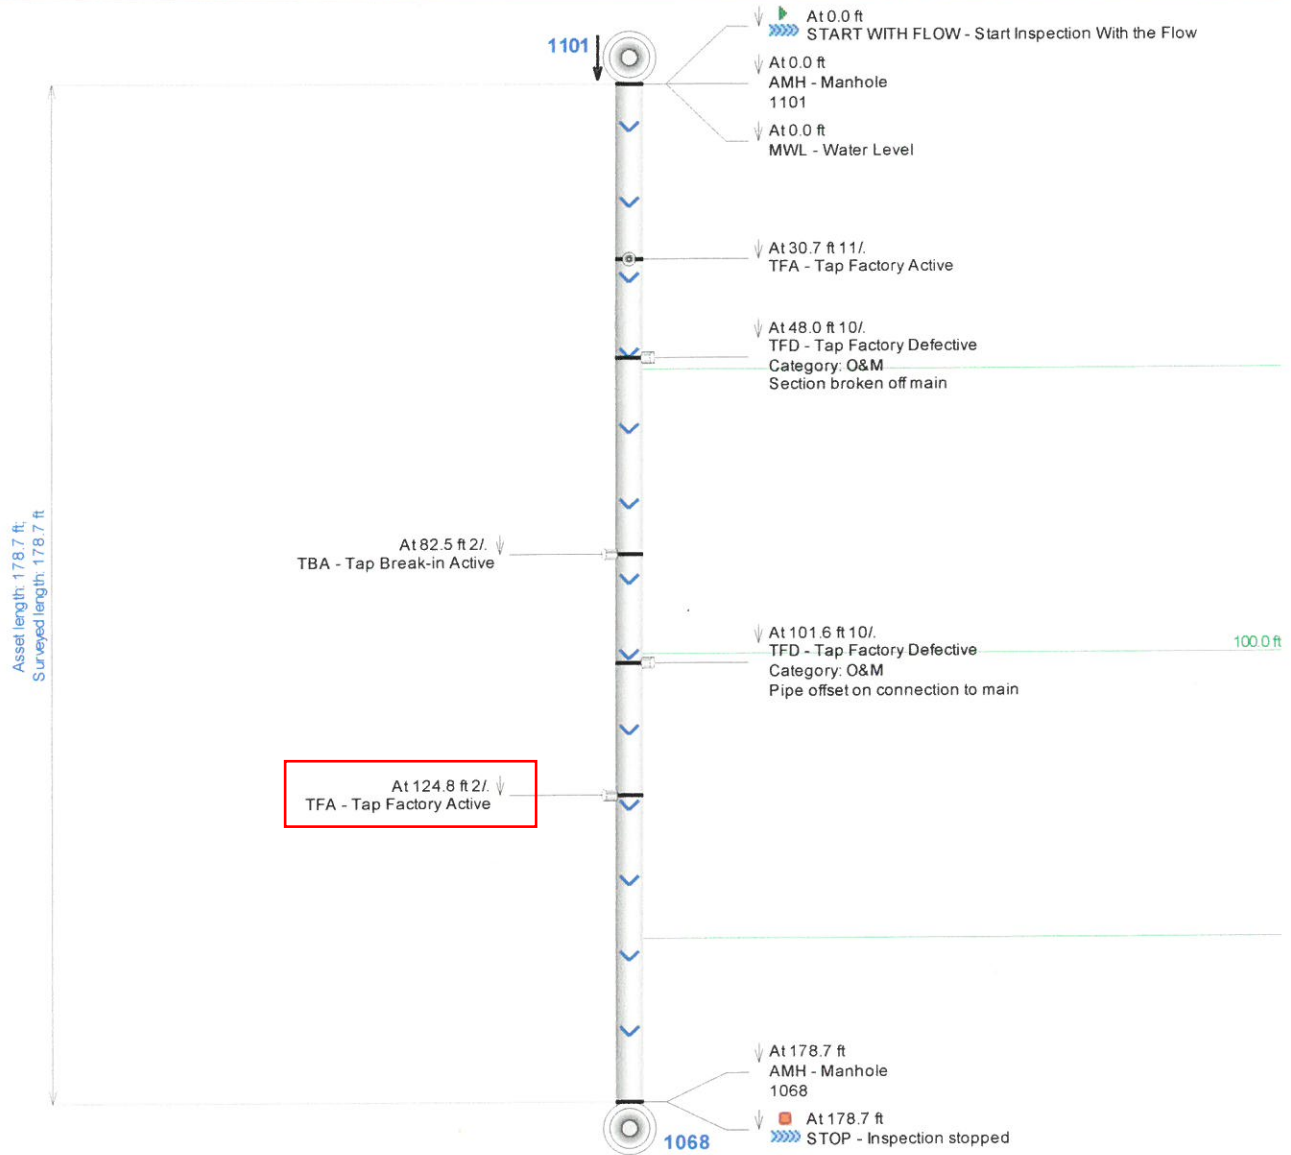
**LATERAL POINT REPAIR #10**

Distance (Feet) (Meters)	Video Ref.	Group/ Descriptor	Modifier/ Severity	Continuous Defect S/M/L	Value		Joint	Circumferential Location	Image Ref.	Remarks
					Inches (mm)	%				
					1st	2nd	At/From	to		
0.0	6	AMH								1101
0.0	18	MWL				5				
30.7	72	TFA			6		11			
48.0	117	TFD			6		10			Section broken off main
82.5	205	TBA			6		2			
101.6	264	TFD			6		10			
124.8	376	TFA			6		2			Pipe offset on connection to main
178.7	463	AMH								1068

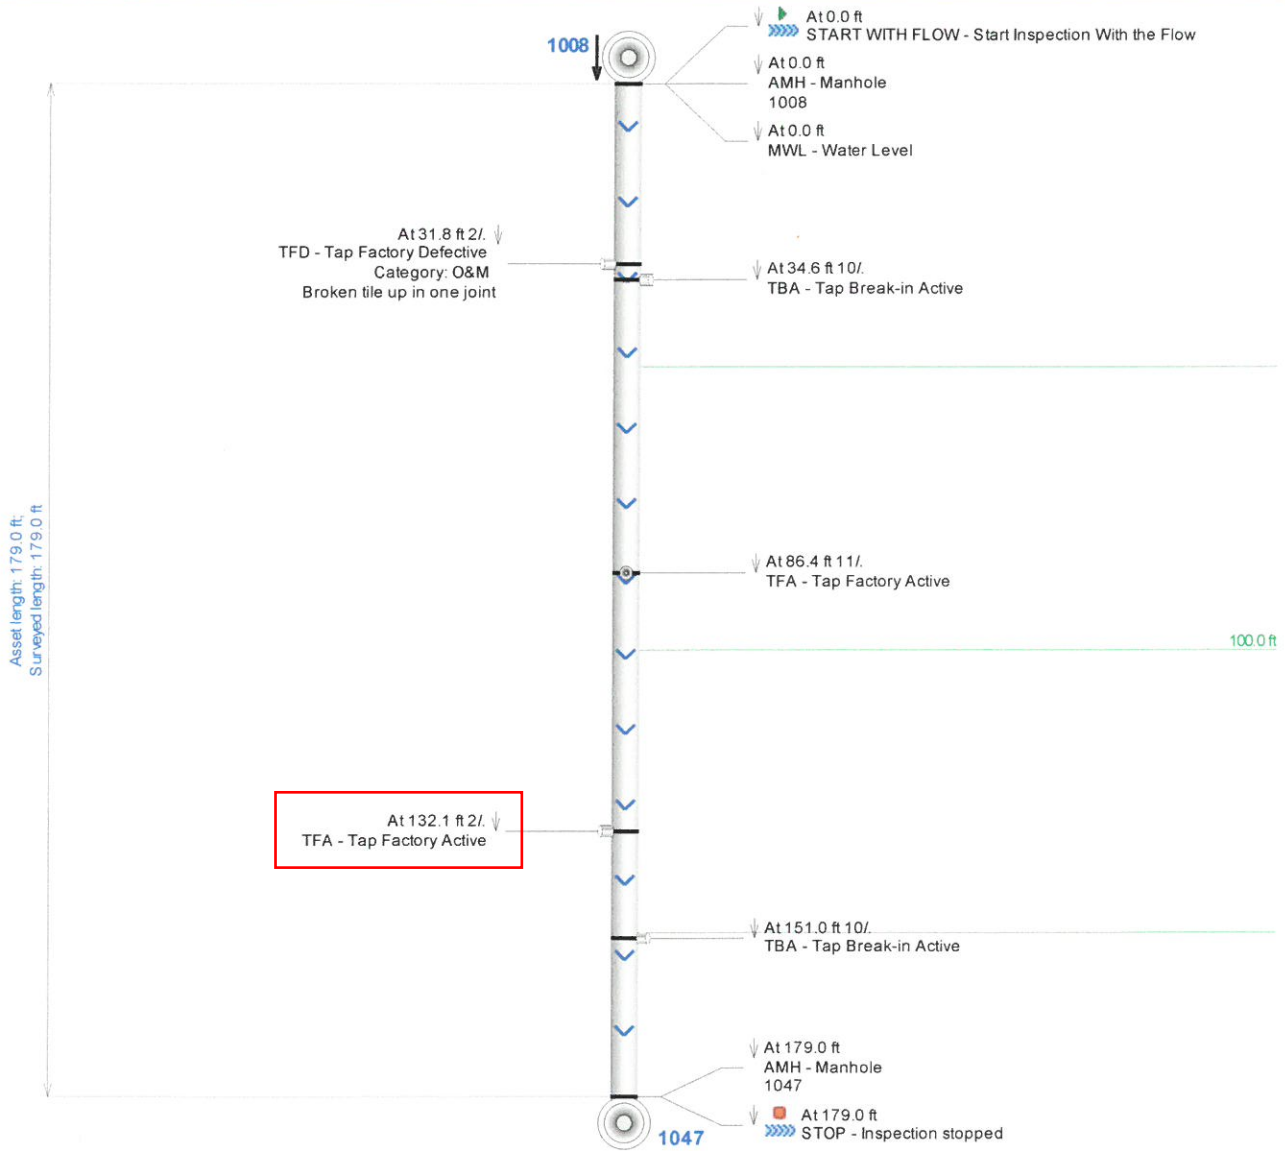
**LATERAL POINT REPAIR #11**

Distance (Feet) (Meters)	Video Ref.	Group/ Descriptor	Modifier/ Severity	Continuous Defect S/M/L	Value		Joint	Circumferential Location	Image Ref.	Remarks
					Inches (mm)	%				
					1st	2nd	Al/From	to		
0.0	1	AMH								1008
0.0	10	MWL				5				
31.8	89	TFD			6		2			Broken tile up in one joint
34.6	134	TBA			6		10			
86.4	229	TFA			6		11			
132.1	319	TFA			6		2			
151.0	383	TBA			6		10			
179.0	480	AMH								1047

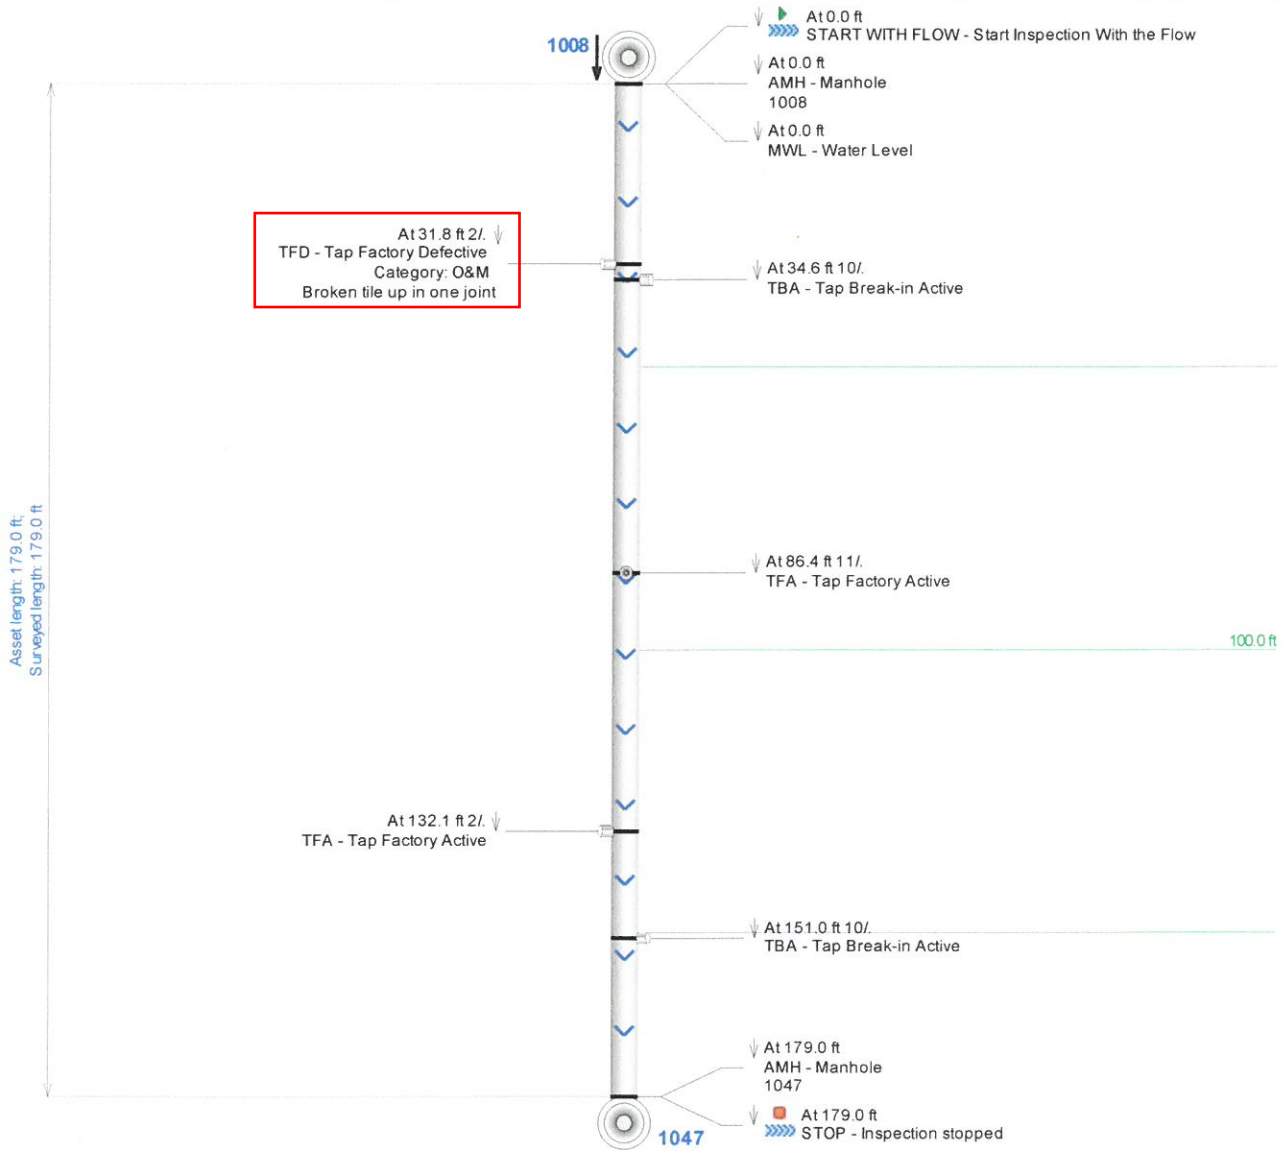
**LATERAL POINT REPAIR #12**

Distance (Feet) (Meters)	Video Ref.	Group/ Descriptor	Modifier/ Severity	Continuous Defect S/M/L	Value		Joint	Circumferential Location	Image Ref.	Remarks
					Inches (mm)	%				
					1st	2nd	Al/From	to		
0.0	1	AMH								1008
0.0	10	MWL				5				
31.8	89	TFD			6		2			Broken tile up in one joint
34.6	134	TBA			6		10			
86.4	229	TFA			6		11			
132.1	319	TFA			6		2			
151.0	383	TBA			6		10			
179.0	480	AMH								1047

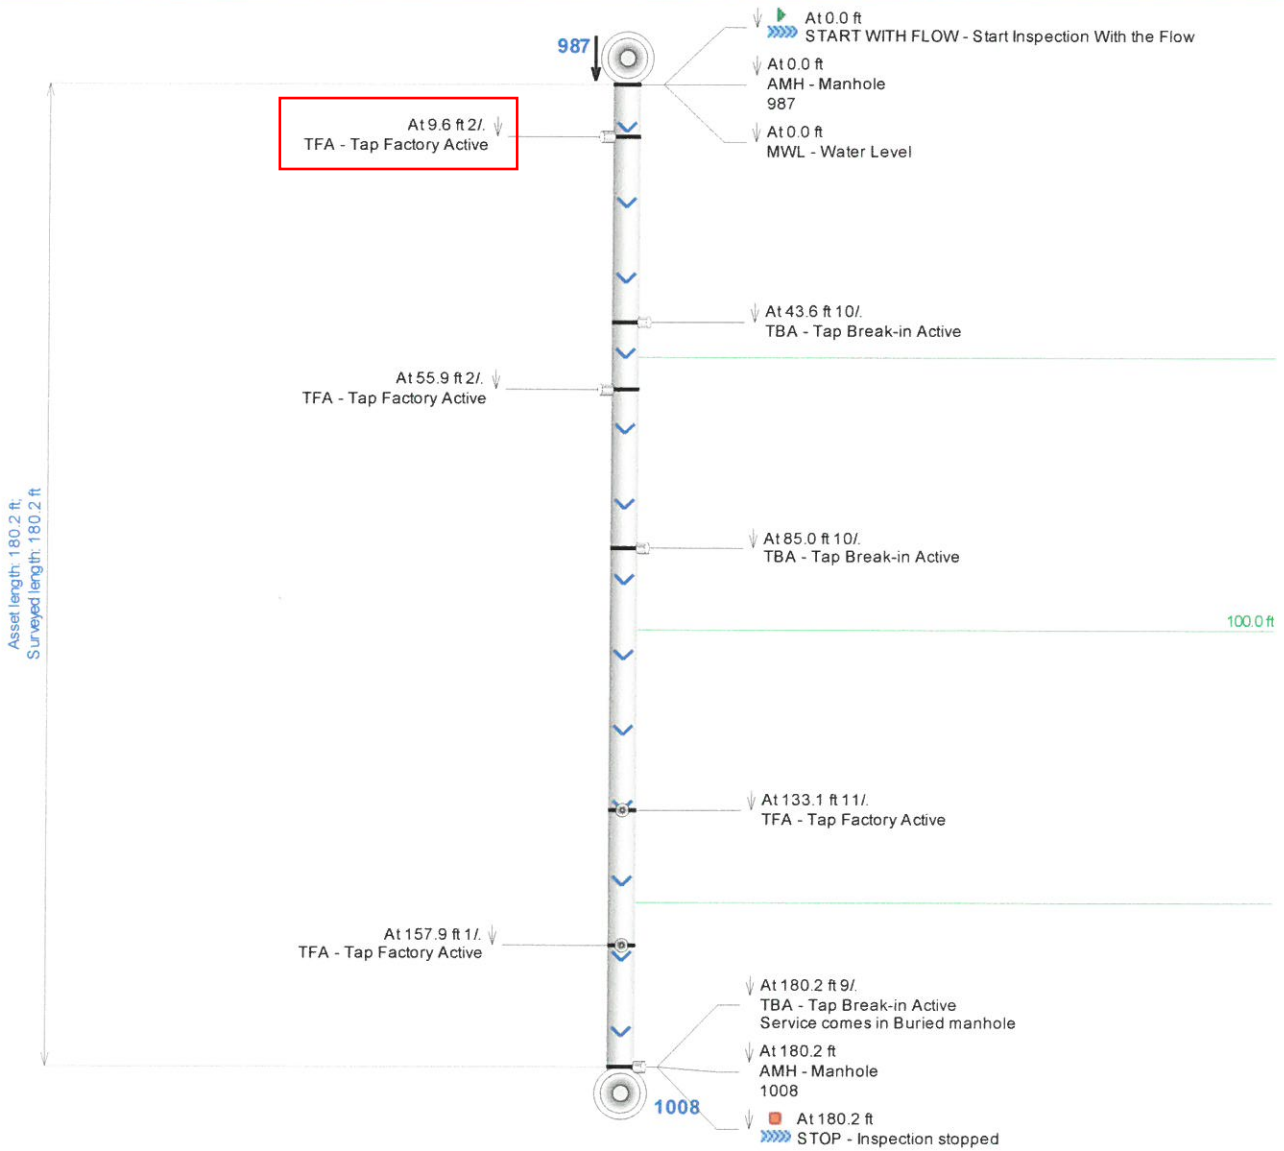
**LATERAL POINT REPAIR #13**

Distance (Feet) (Meters)	Video Ref.	Group/ Descriptor	Modifier/ Severity	S/M/L	Value		Joint	Circumferential Location	Image Ref.	Remarks
					Inches (mm) 1st	2nd				
0.0	1	AMH								987
0.0	15	MWL				5				
9.6	54	TFA			6		2			
43.6	118	TBA			6		10			
55.9	172	TFA			6		2			
85.0	264	TBA			6		10			
133.1	346	TFA			6		11			
157.9	413	TFA			6		1			
180.2	483	TBA			6		9			Service comes in Buried manhole

Distance (Feet) (Meters)	Video Ref.	Group/ Descriptor	Modifier/ Severity	Continuous Defect	S/M/L	Value Inches (mm)		Joint	Circumferential Location	Image Ref.	Remarks
						1st	2nd				
180.2	510	AMH									1008
