CITY OF JOLIET

2016 HALDEMANN TERRACE LATERAL POINT REPAIRS

CONTRACT NO. 2151-0416

INDEX OF SHEETS

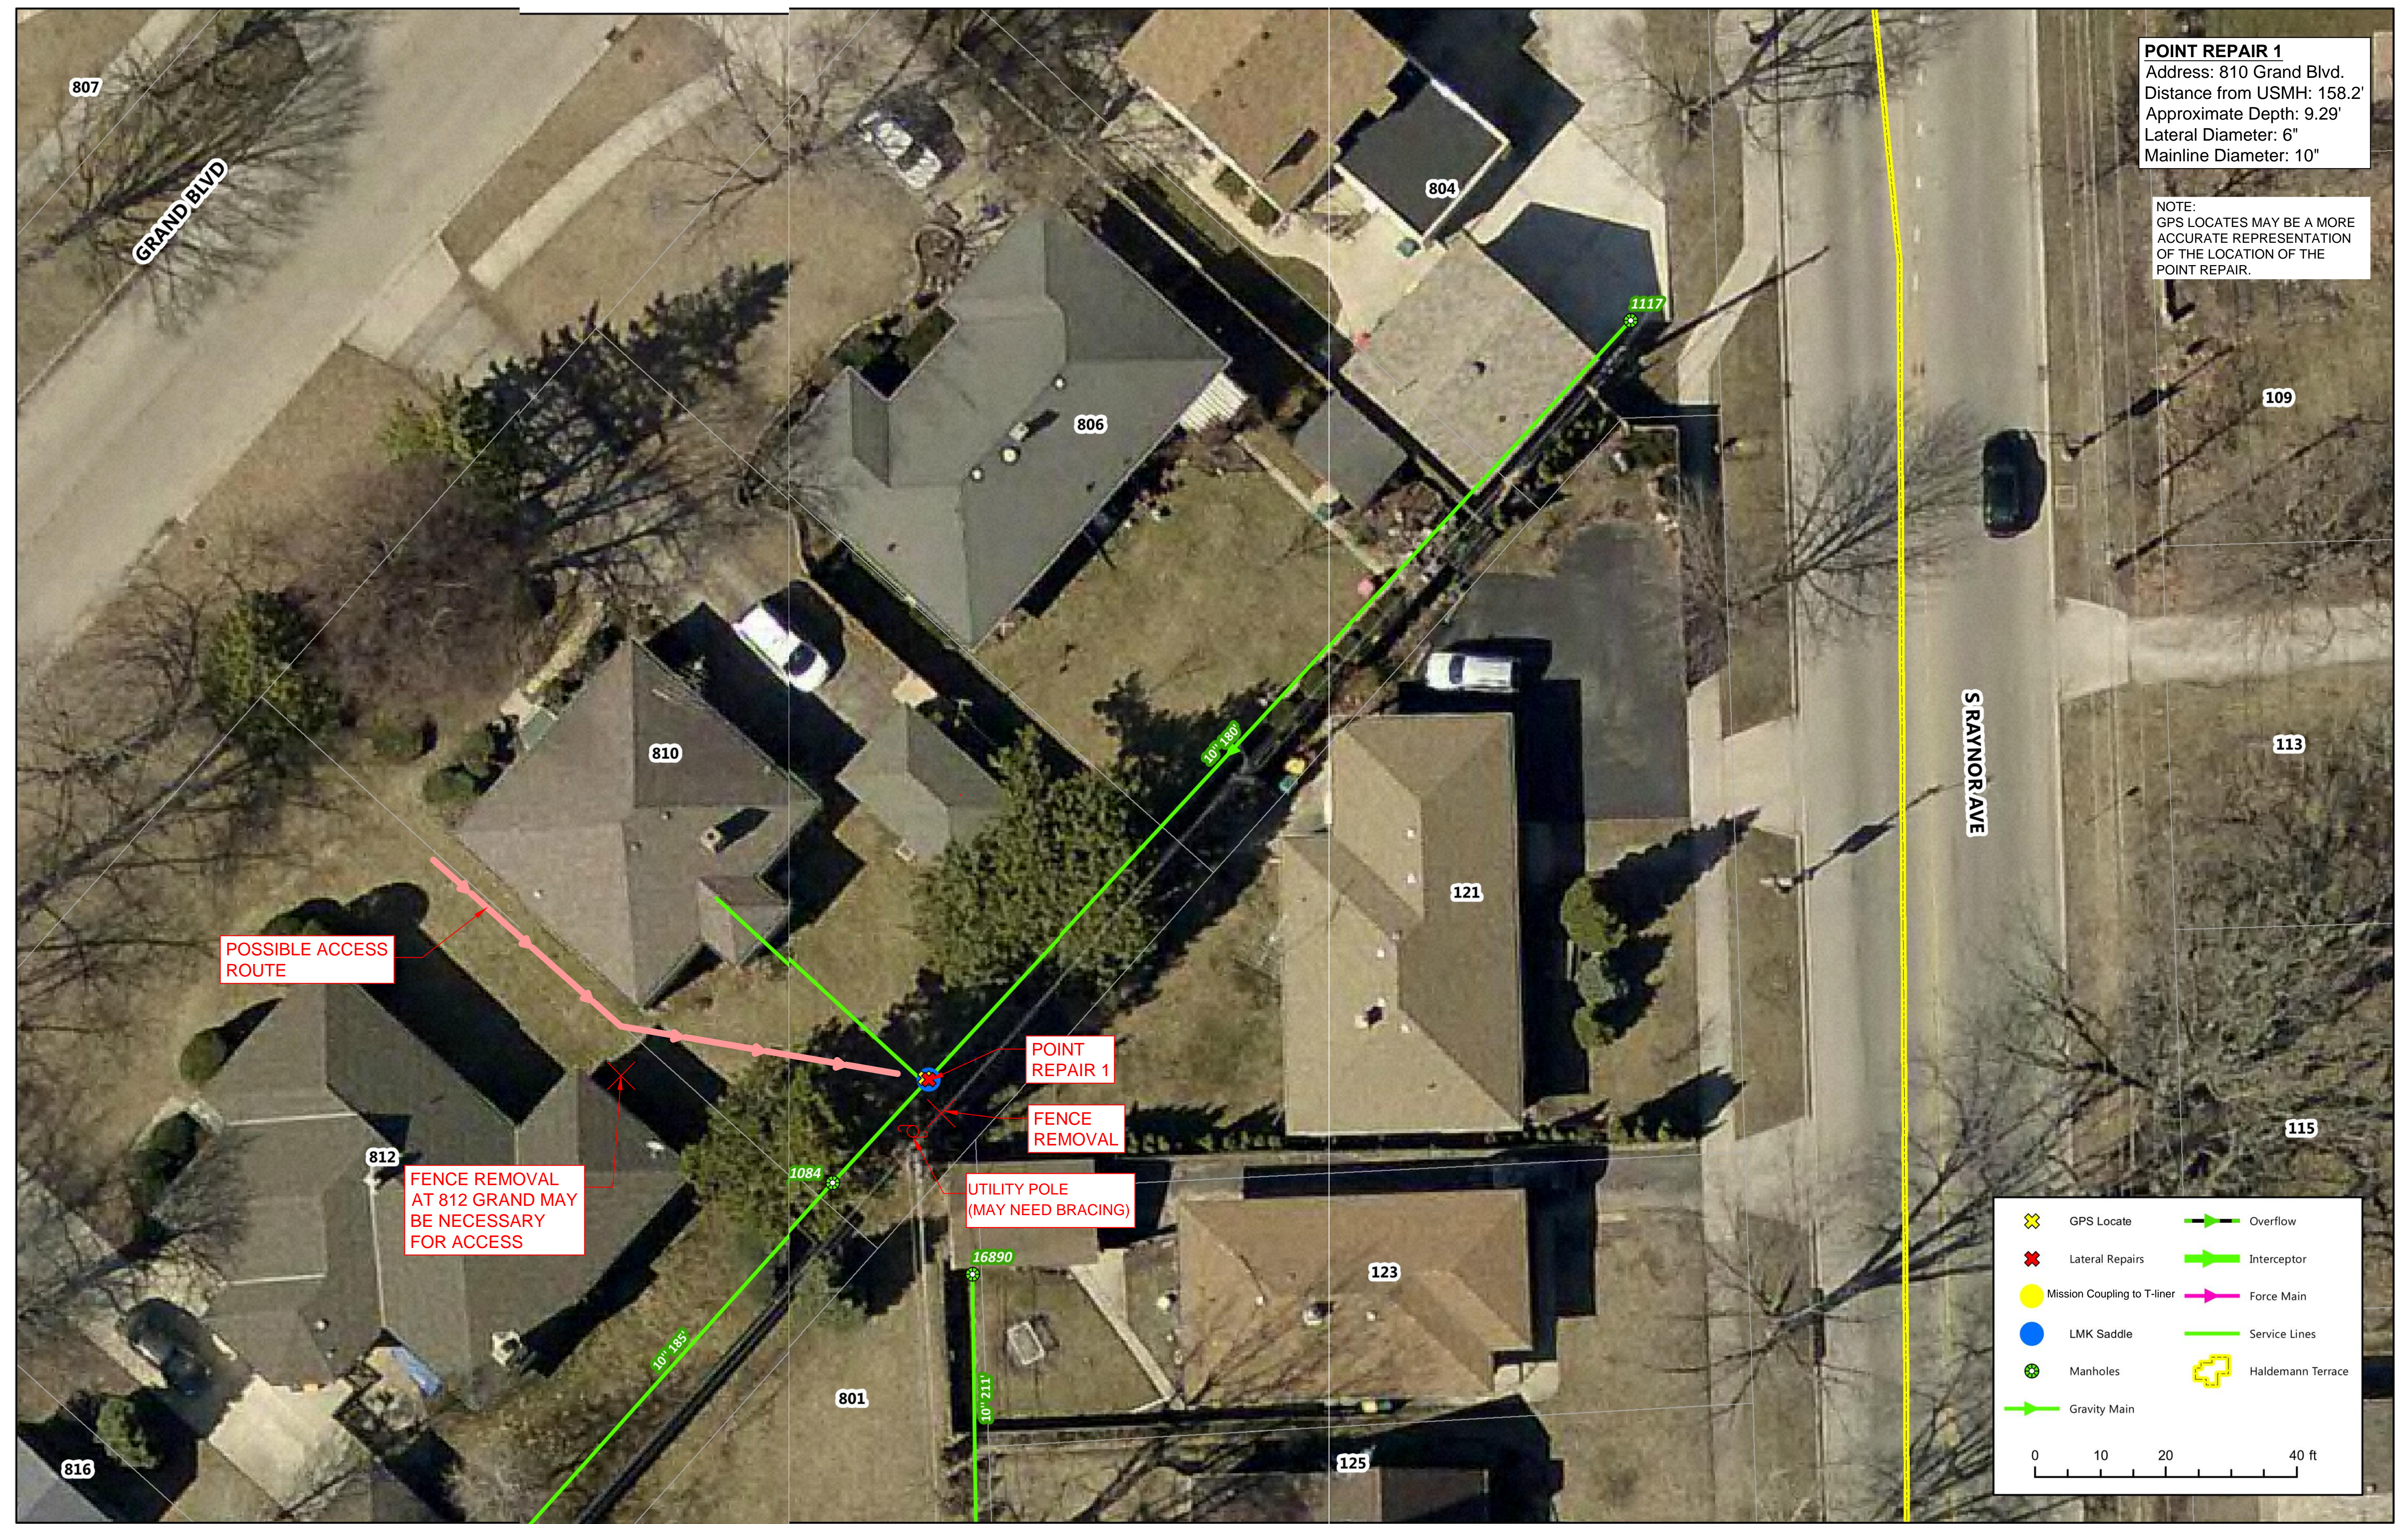
POINT REPAIR 1
 Address: 810 Grand Blvd.
 Distance from USMH: 158.2'
 Approximate Depth: 9.29'
 Lateral Diameter: 6"
 Mainline Diameter: 10"

NOTE:
 GPS LOCATES MAY BE A MORE
 ACCURATE REPRESENTATION
 OF THE LOCATION OF THE
 POINT REPAIR.

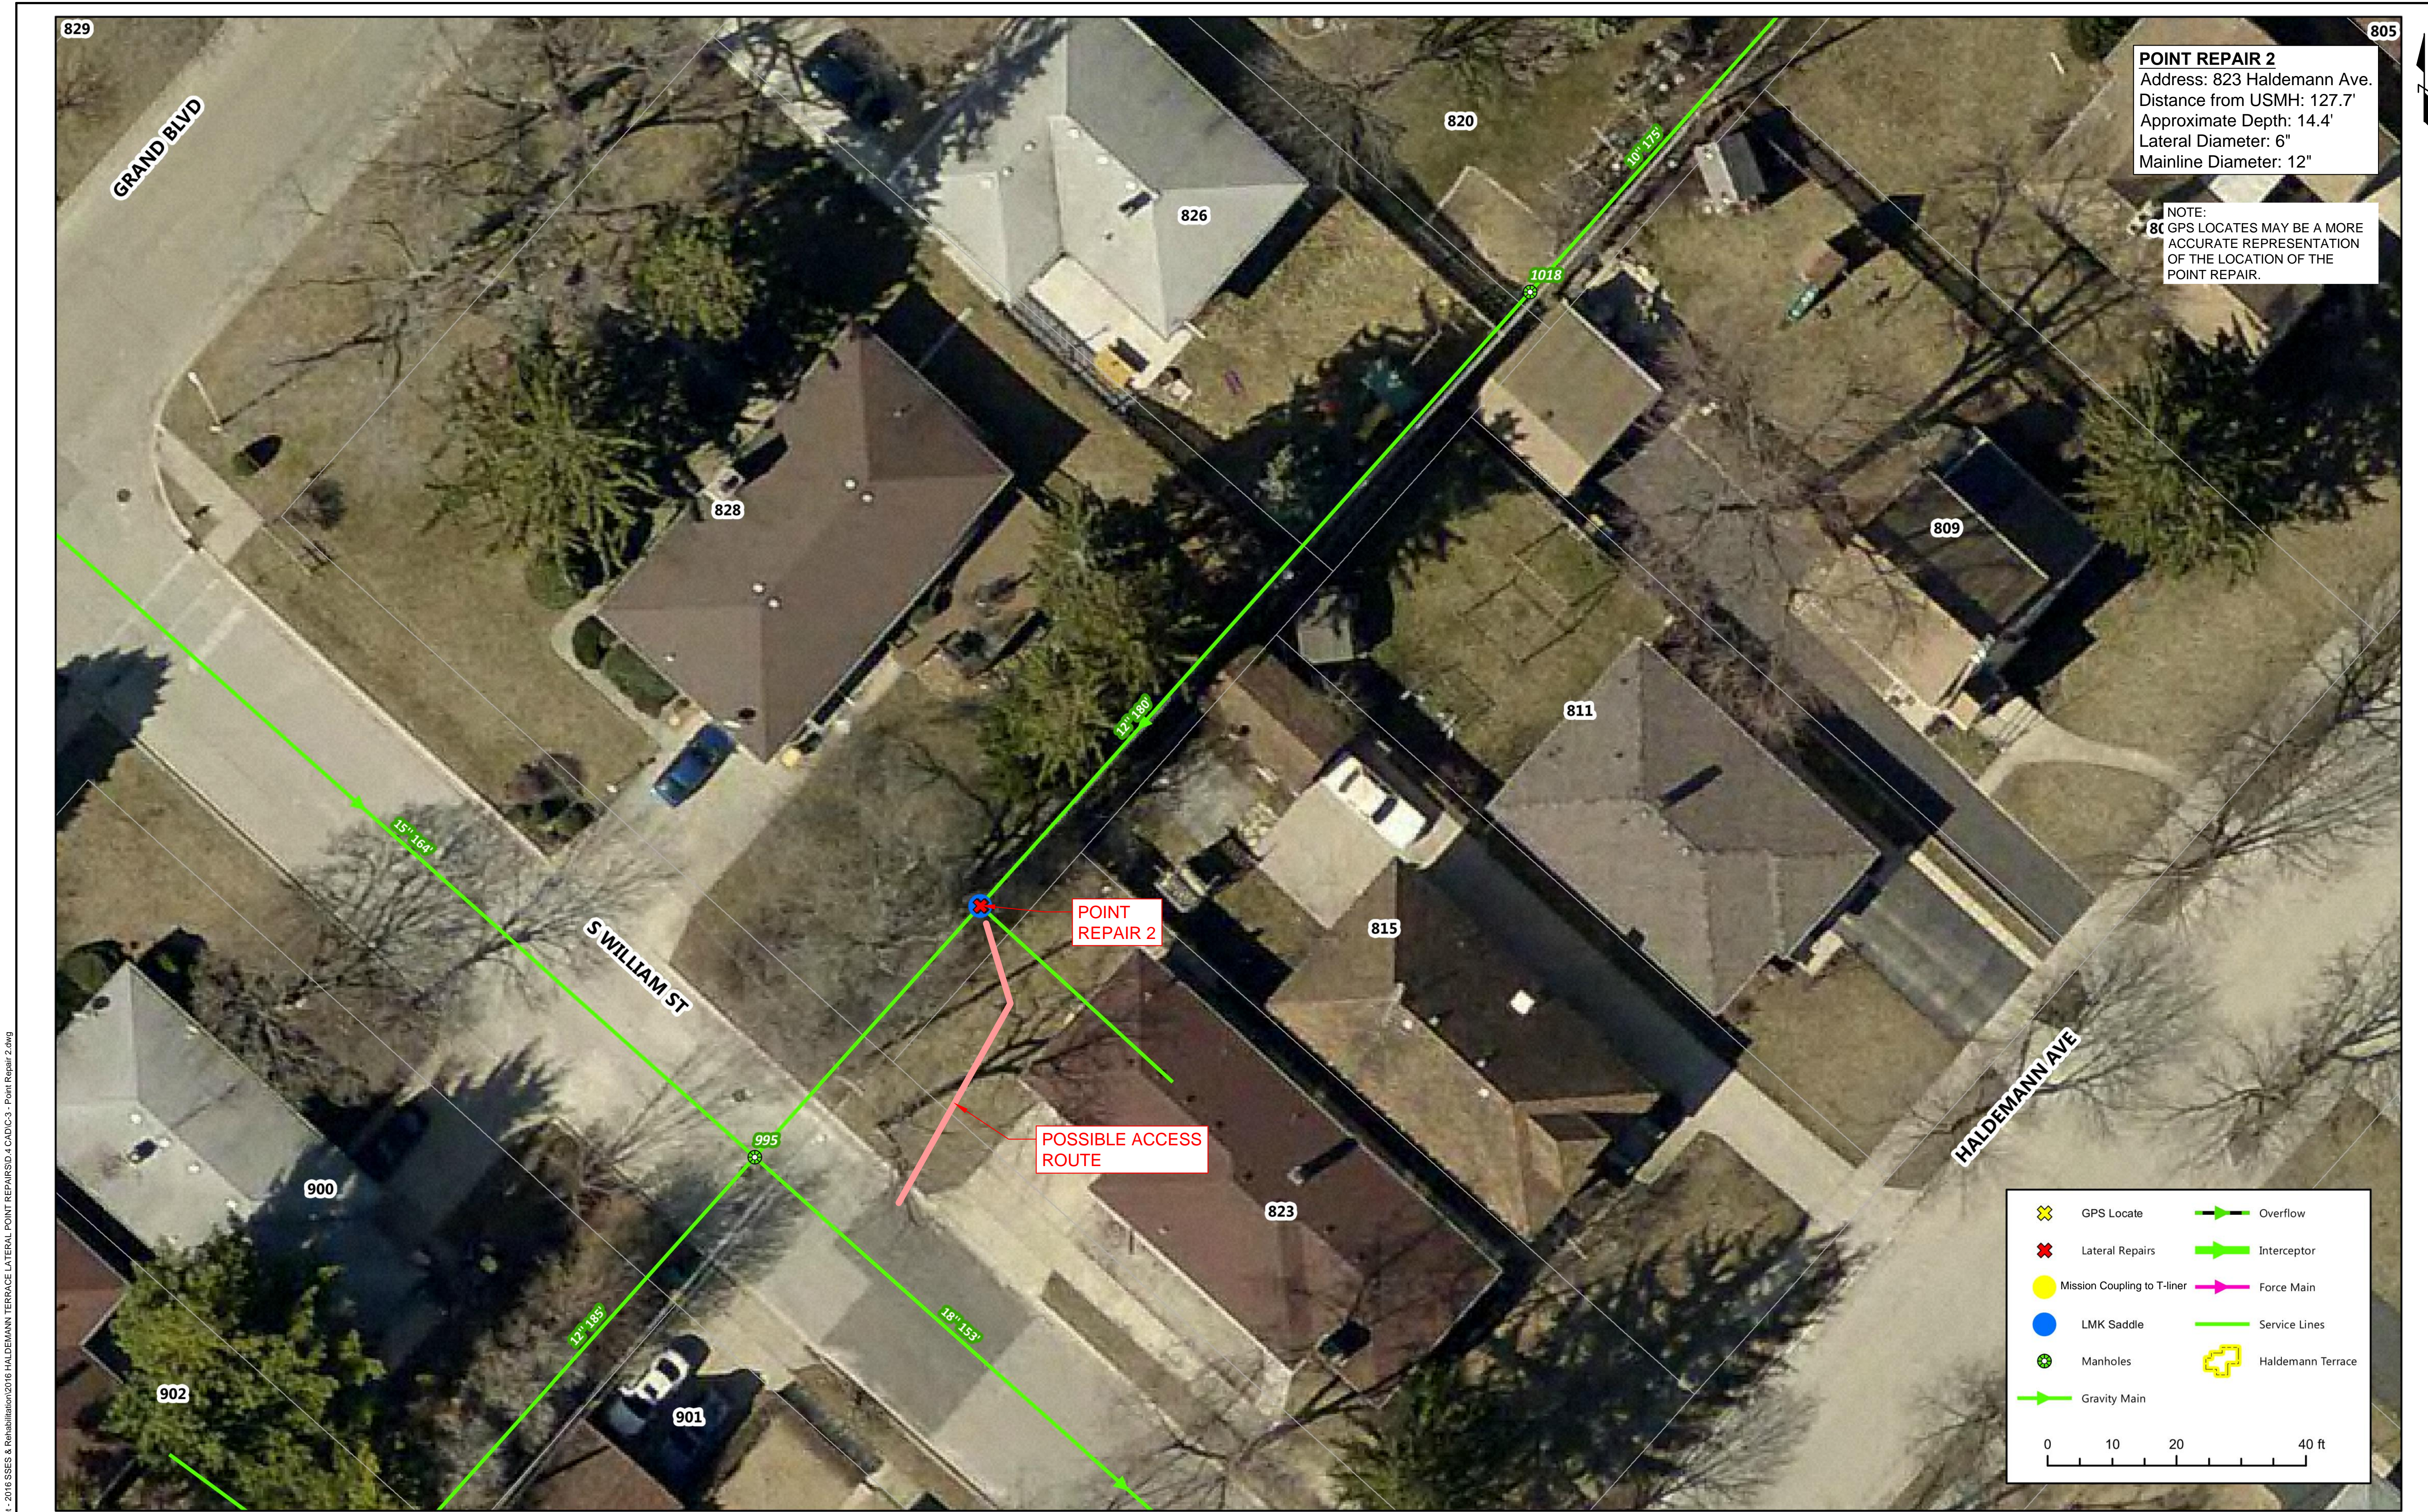
POINT REPAIR 2
 Address: 823 Haldemann Ave.
 Distance from USMH: 127.7'
 Approximate Depth: 14.4'
 Lateral Diameter: 6"
 Mainline Diameter: 12"

NOTE:
 GPS LOCATES MAY BE A MORE ACCURATE REPRESENTATION OF THE LOCATION OF THE POINT REPAIR.

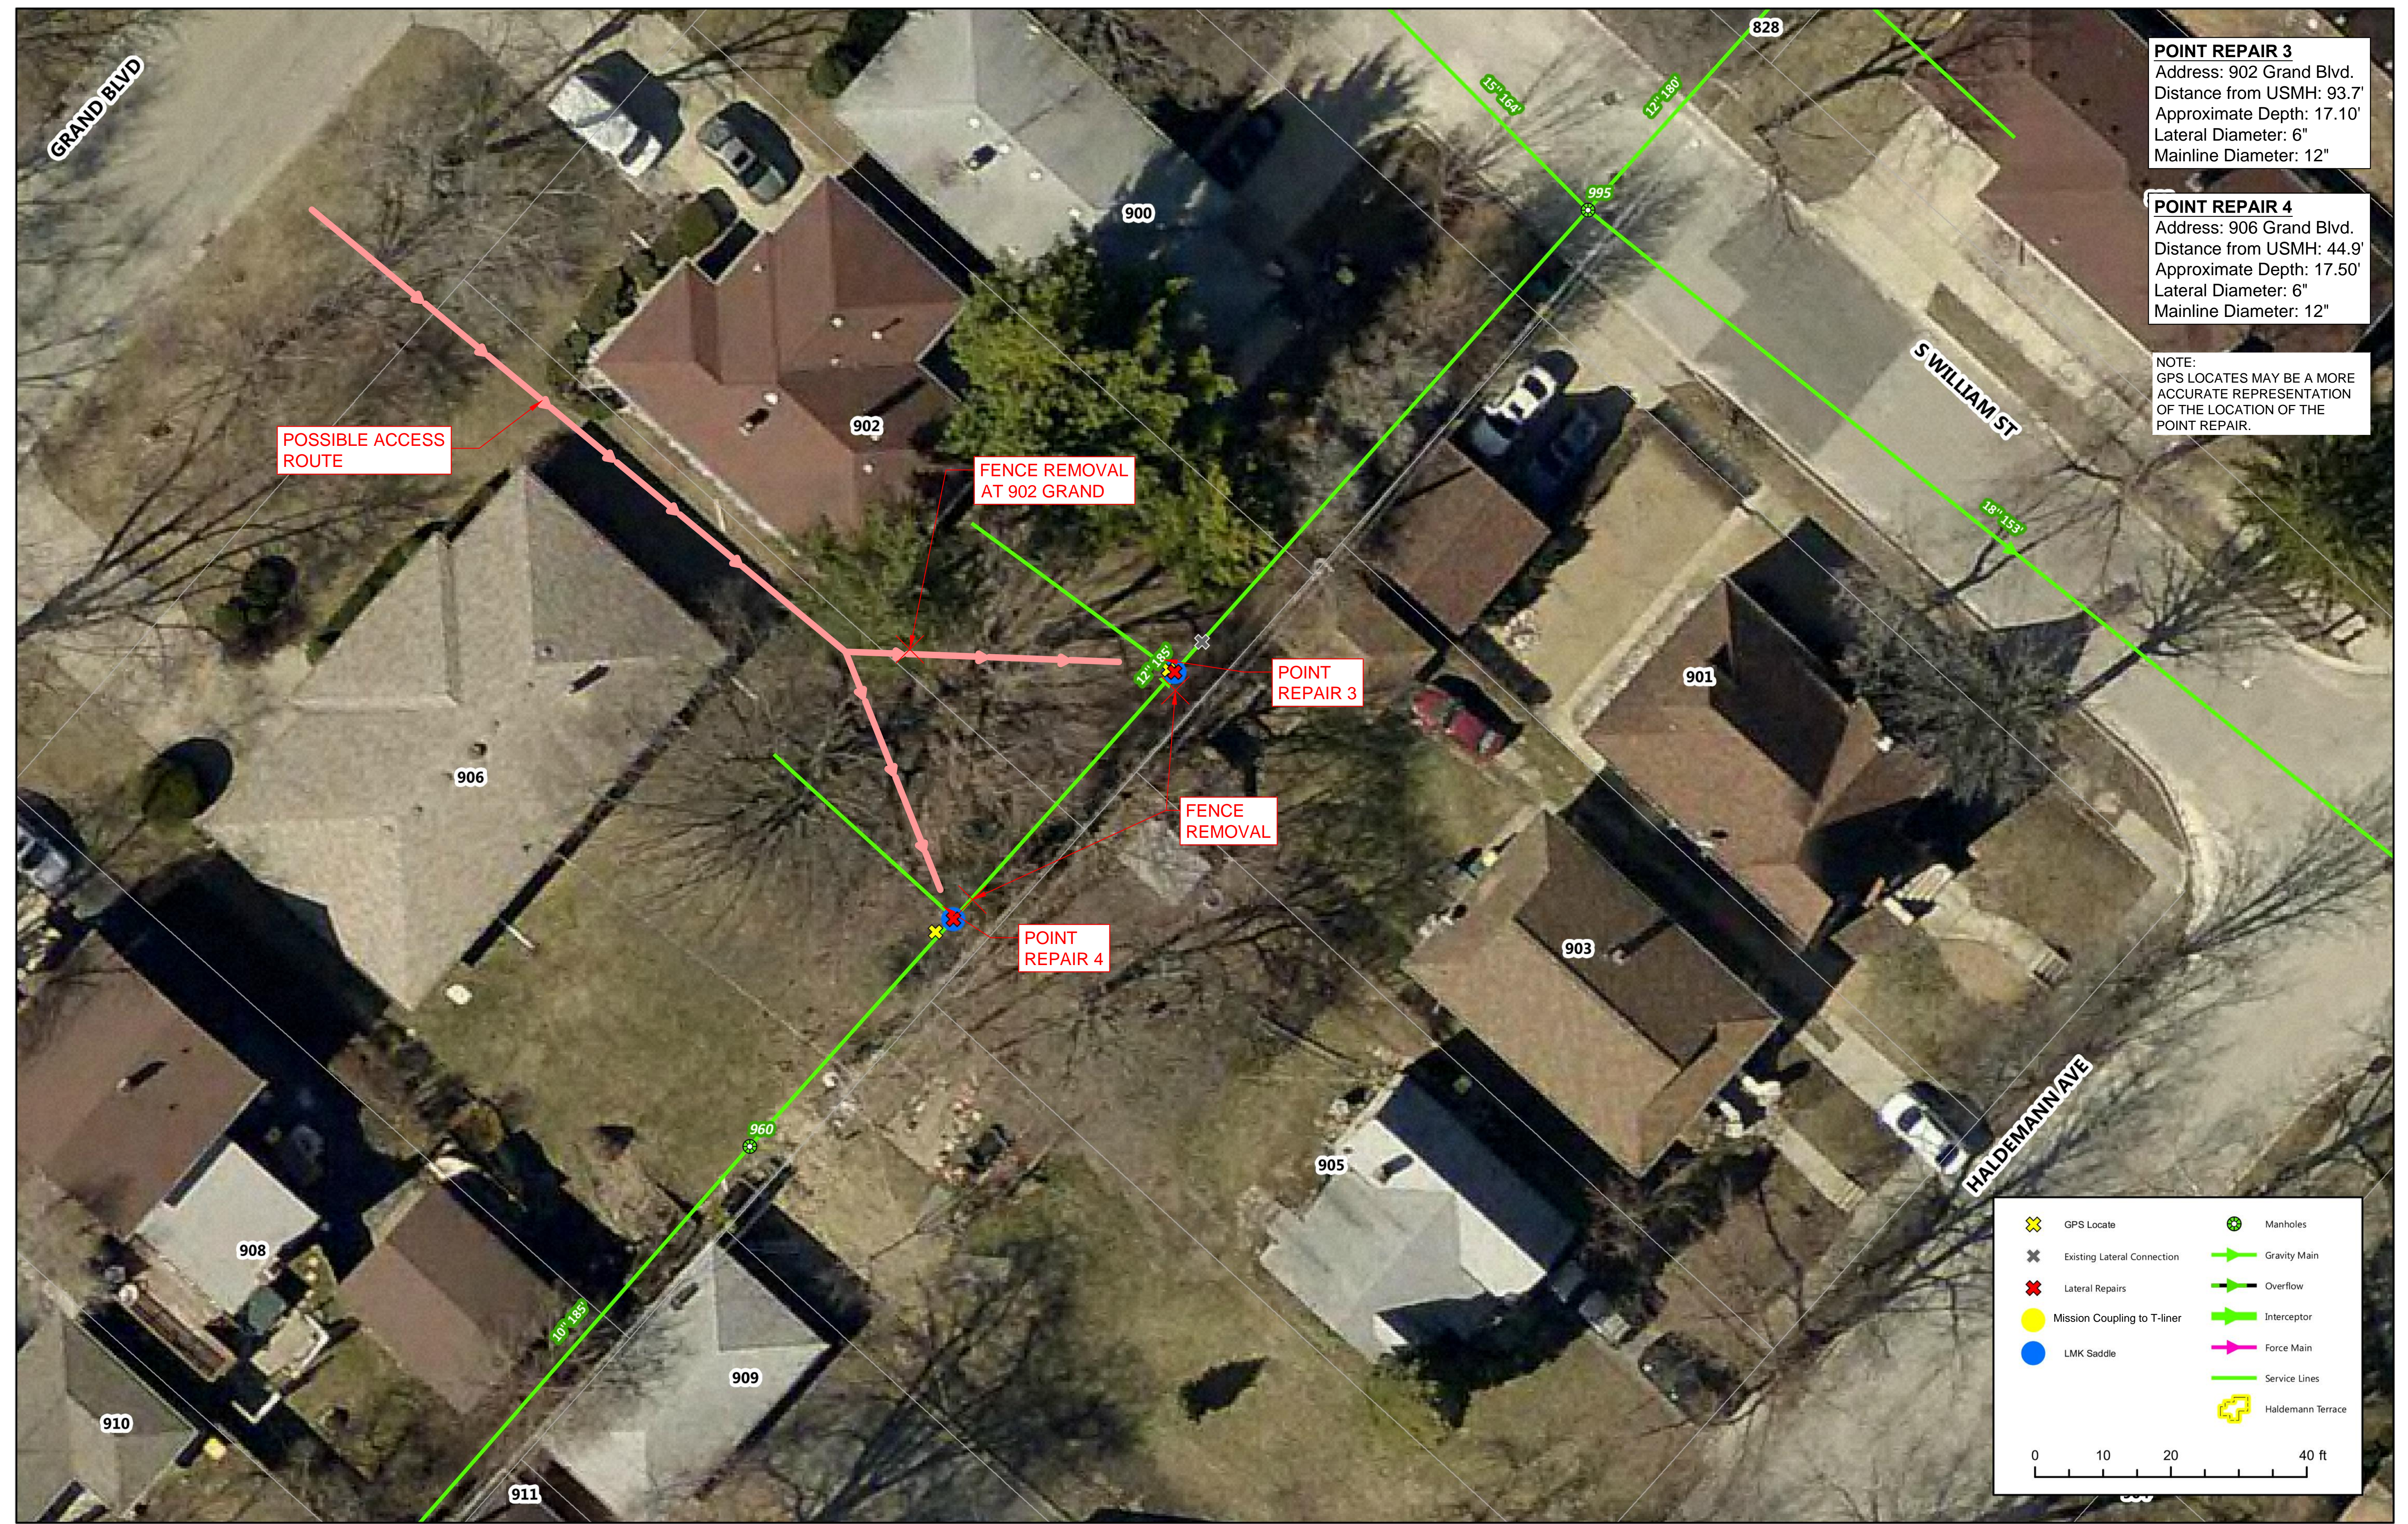
POINT REPAIRS 3 & 4

POINT REPAIR 3
 Address: 902 Grand Blvd.
 Distance from USMH: 93.7'
 Approximate Depth: 17.10'
 Lateral Diameter: 6"
 Mainline Diameter: 12"

POINT REPAIR 4
 Address: 906 Grand Blvd.
 Distance from USMH: 44.9'
 Approximate Depth: 17.50'
 Lateral Diameter: 6"
 Mainline Diameter: 12"

NOTE:
 GPS LOCATES MAY BE A MORE
 ACCURATE REPRESENTATION
 OF THE LOCATION OF THE
 POINT REPAIR.

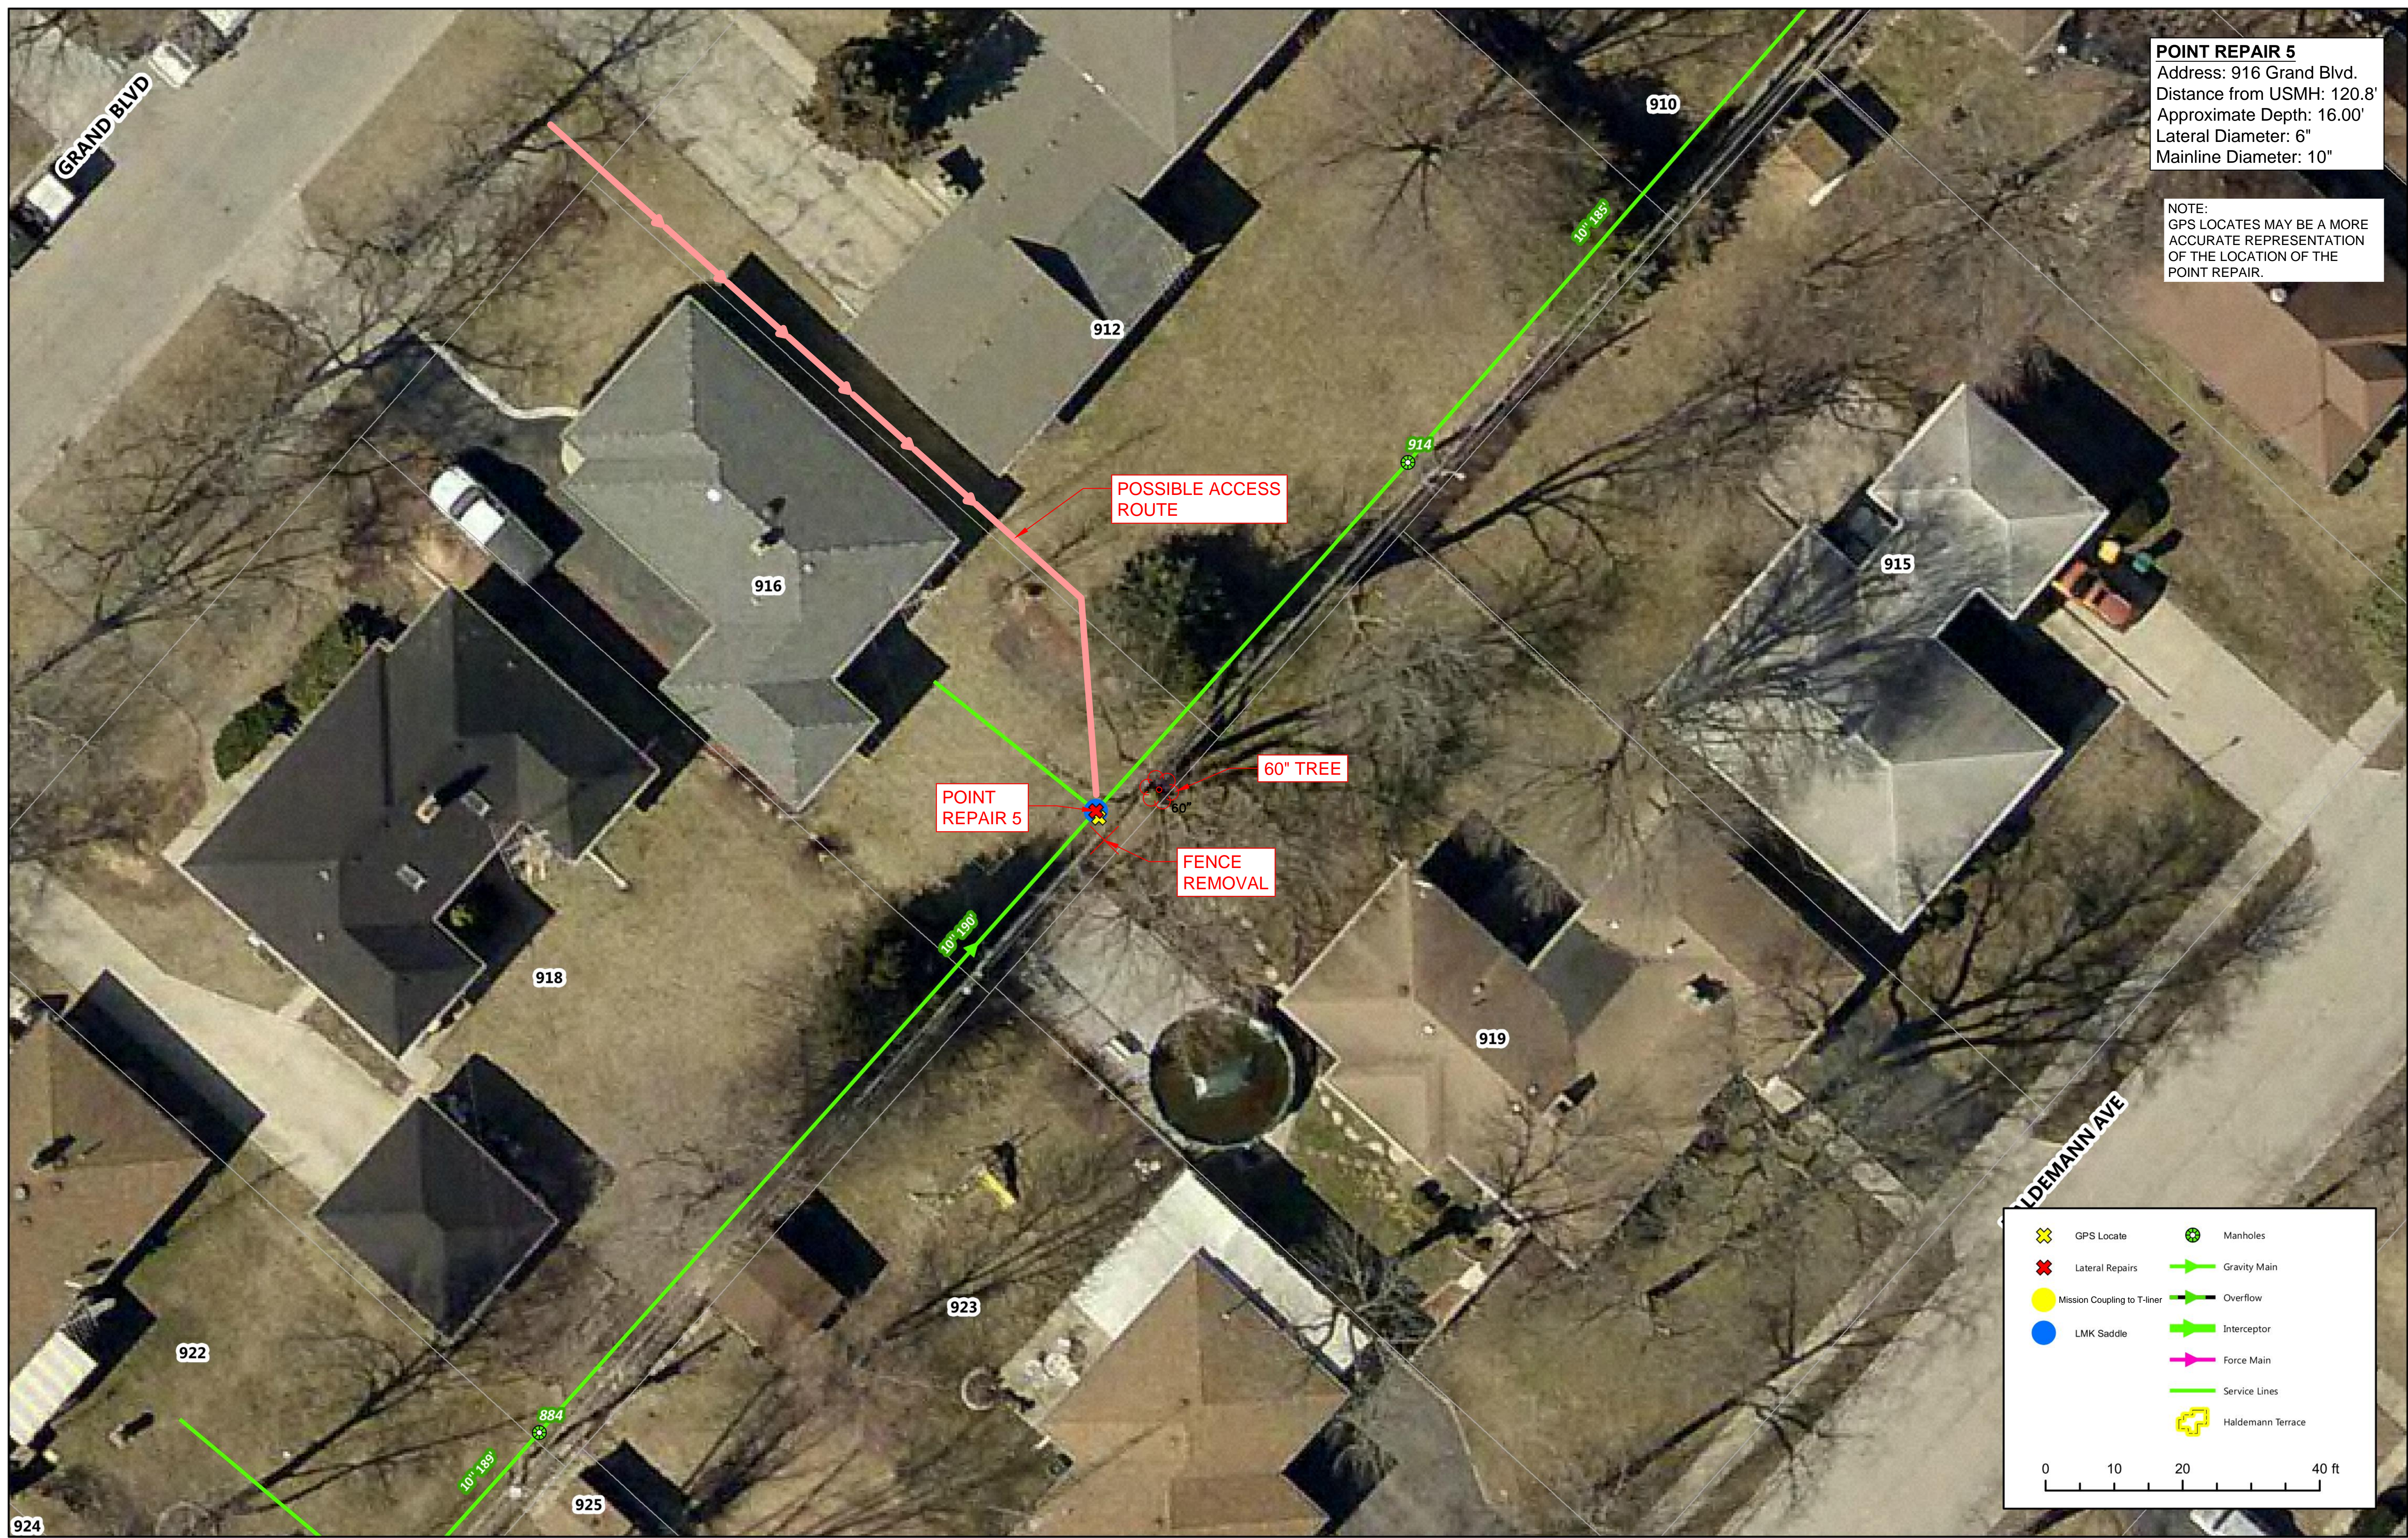
POINT REPAIR 5
 Address: 916 Grand Blvd.
 Distance from USMH: 120.8'
 Approximate Depth: 16.00'
 Lateral Diameter: 6"
 Mainline Diameter: 10"

NOTE:
 GPS LOCATES MAY BE A MORE ACCURATE REPRESENTATION OF THE LOCATION OF THE POINT REPAIR.

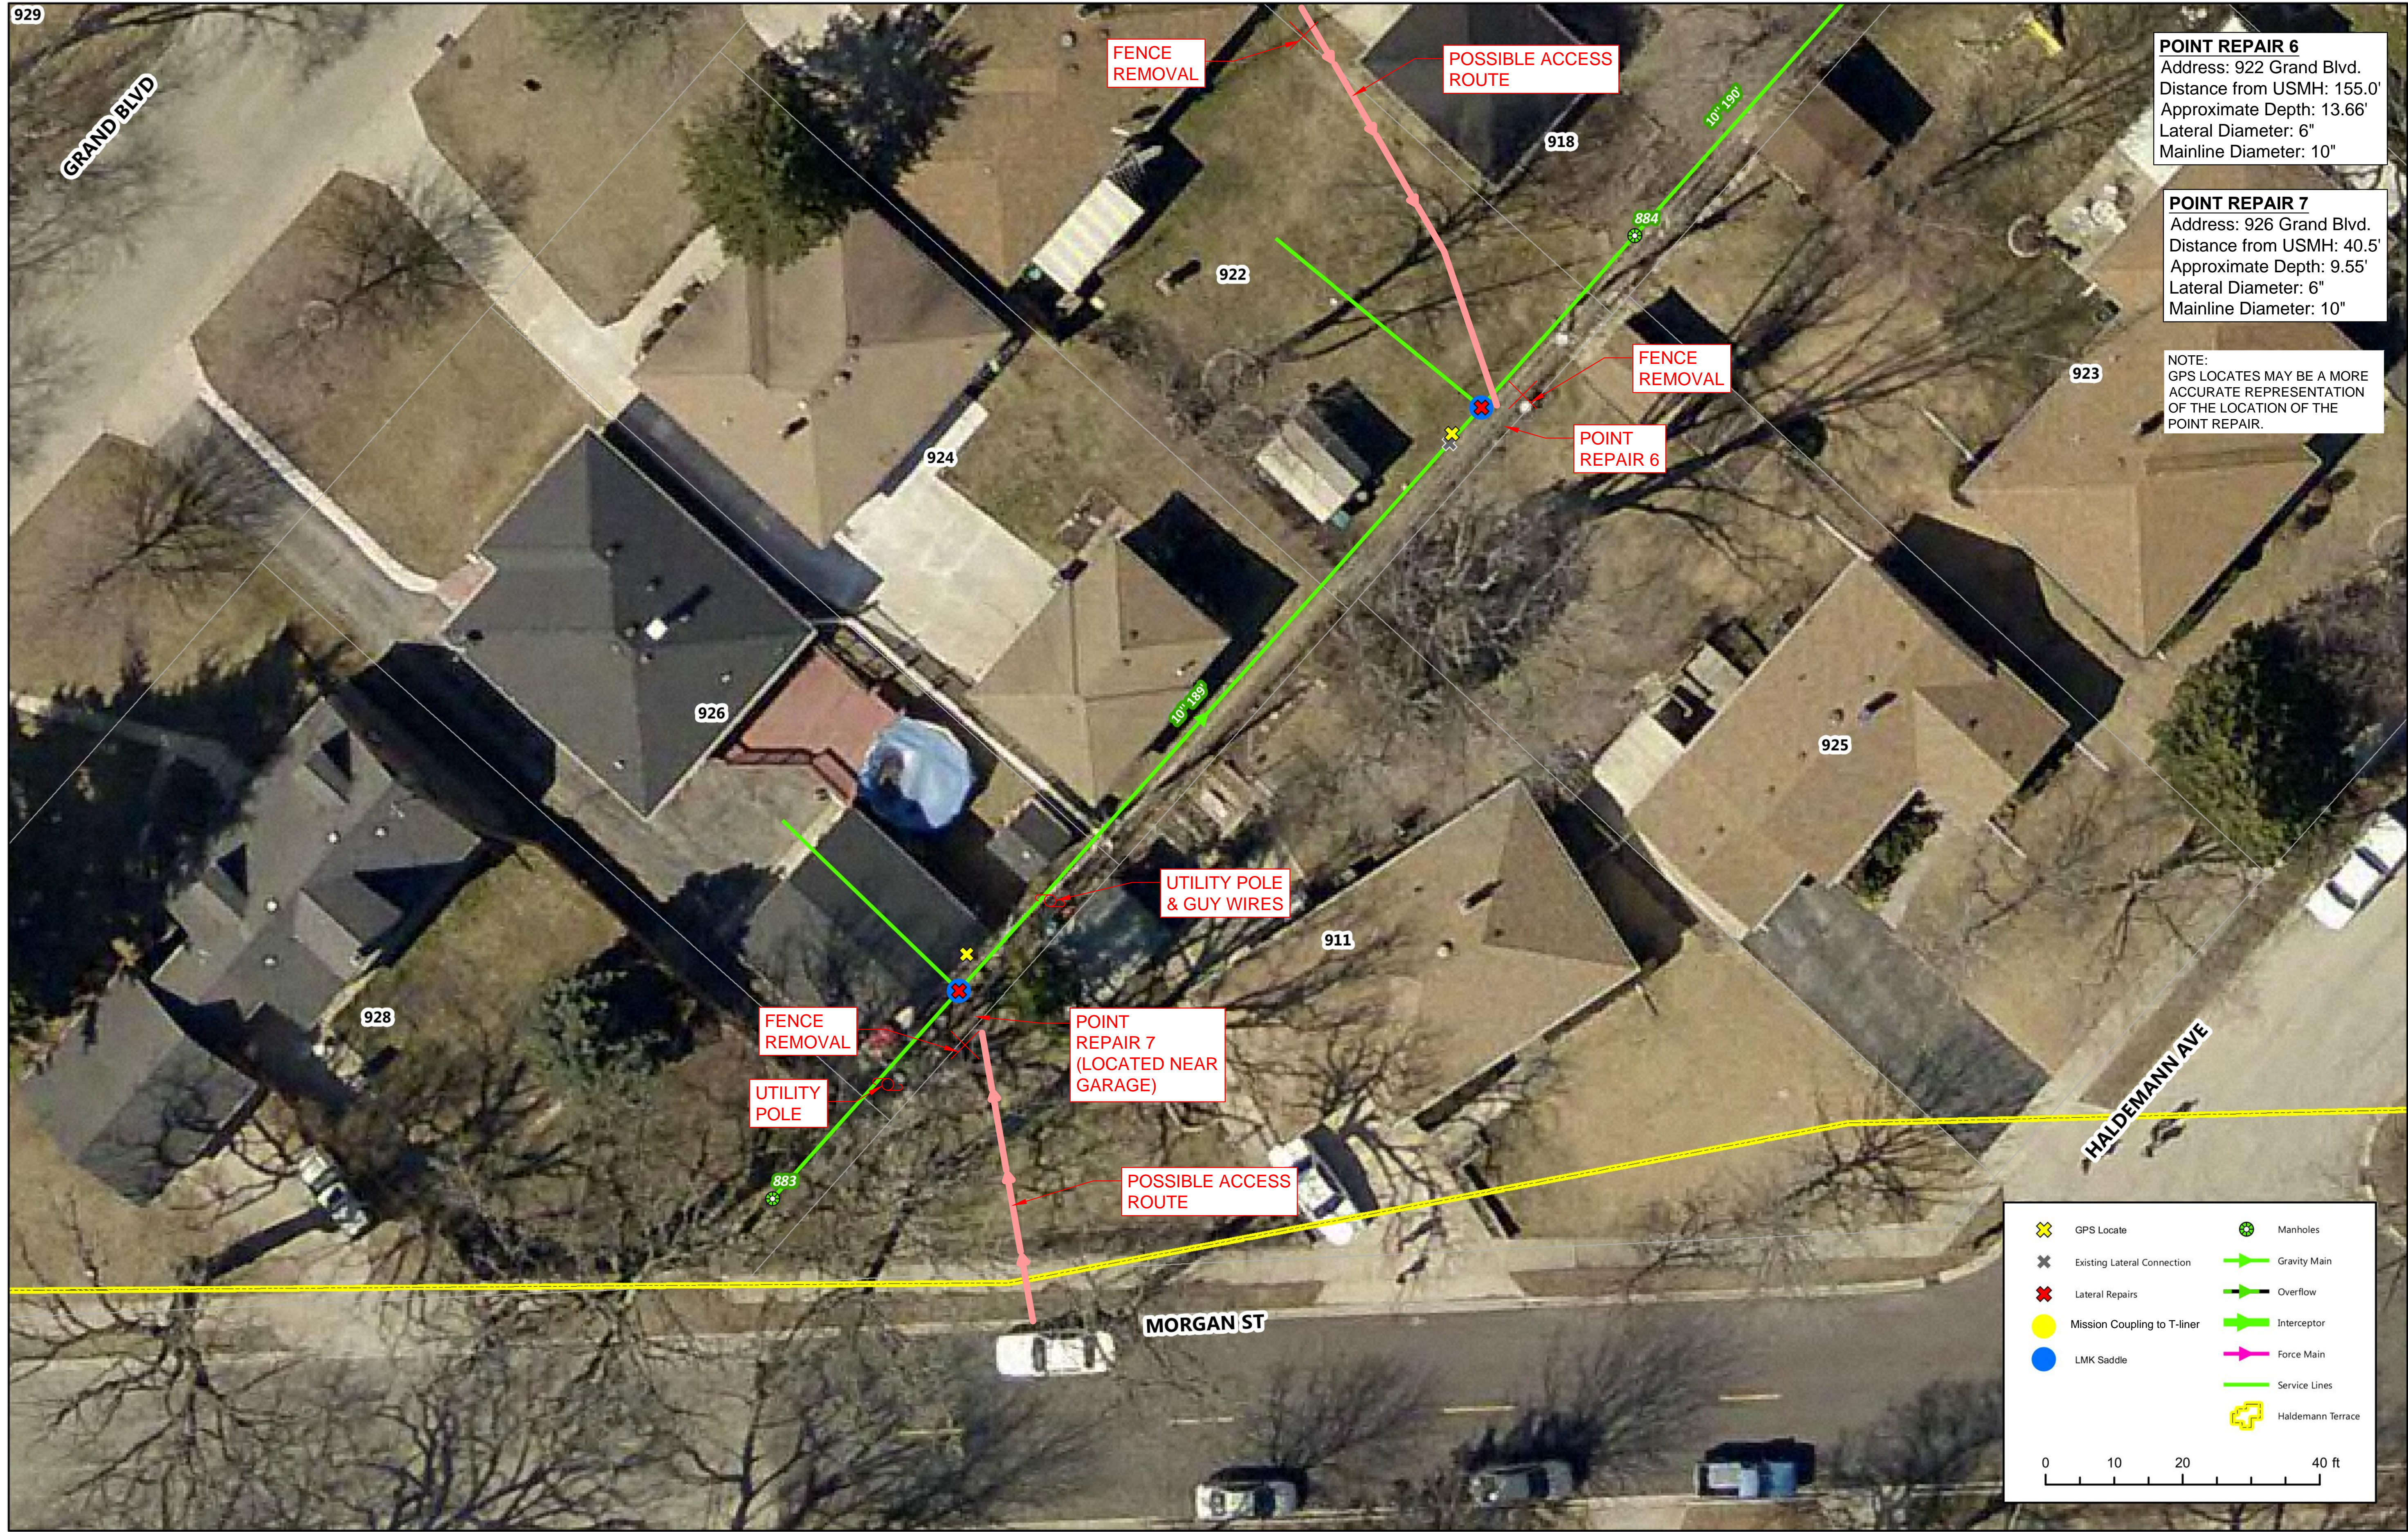
POINT REPAIRS 6 & 7

POINT REPAIR 6
 Address: 922 Grand Blvd.
 Distance from USMH: 155.0'
 Approximate Depth: 13.66'
 Lateral Diameter: 6"
 Mainline Diameter: 10"

POINT REPAIR 7
 Address: 926 Grand Blvd.
 Distance from USMH: 40.5'
 Approximate Depth: 9.55'
 Lateral Diameter: 6"
 Mainline Diameter: 10"

NOTE:
 GPS LOCATES MAY BE A MORE
 ACCURATE REPRESENTATION
 OF THE LOCATION OF THE
 POINT REPAIR.

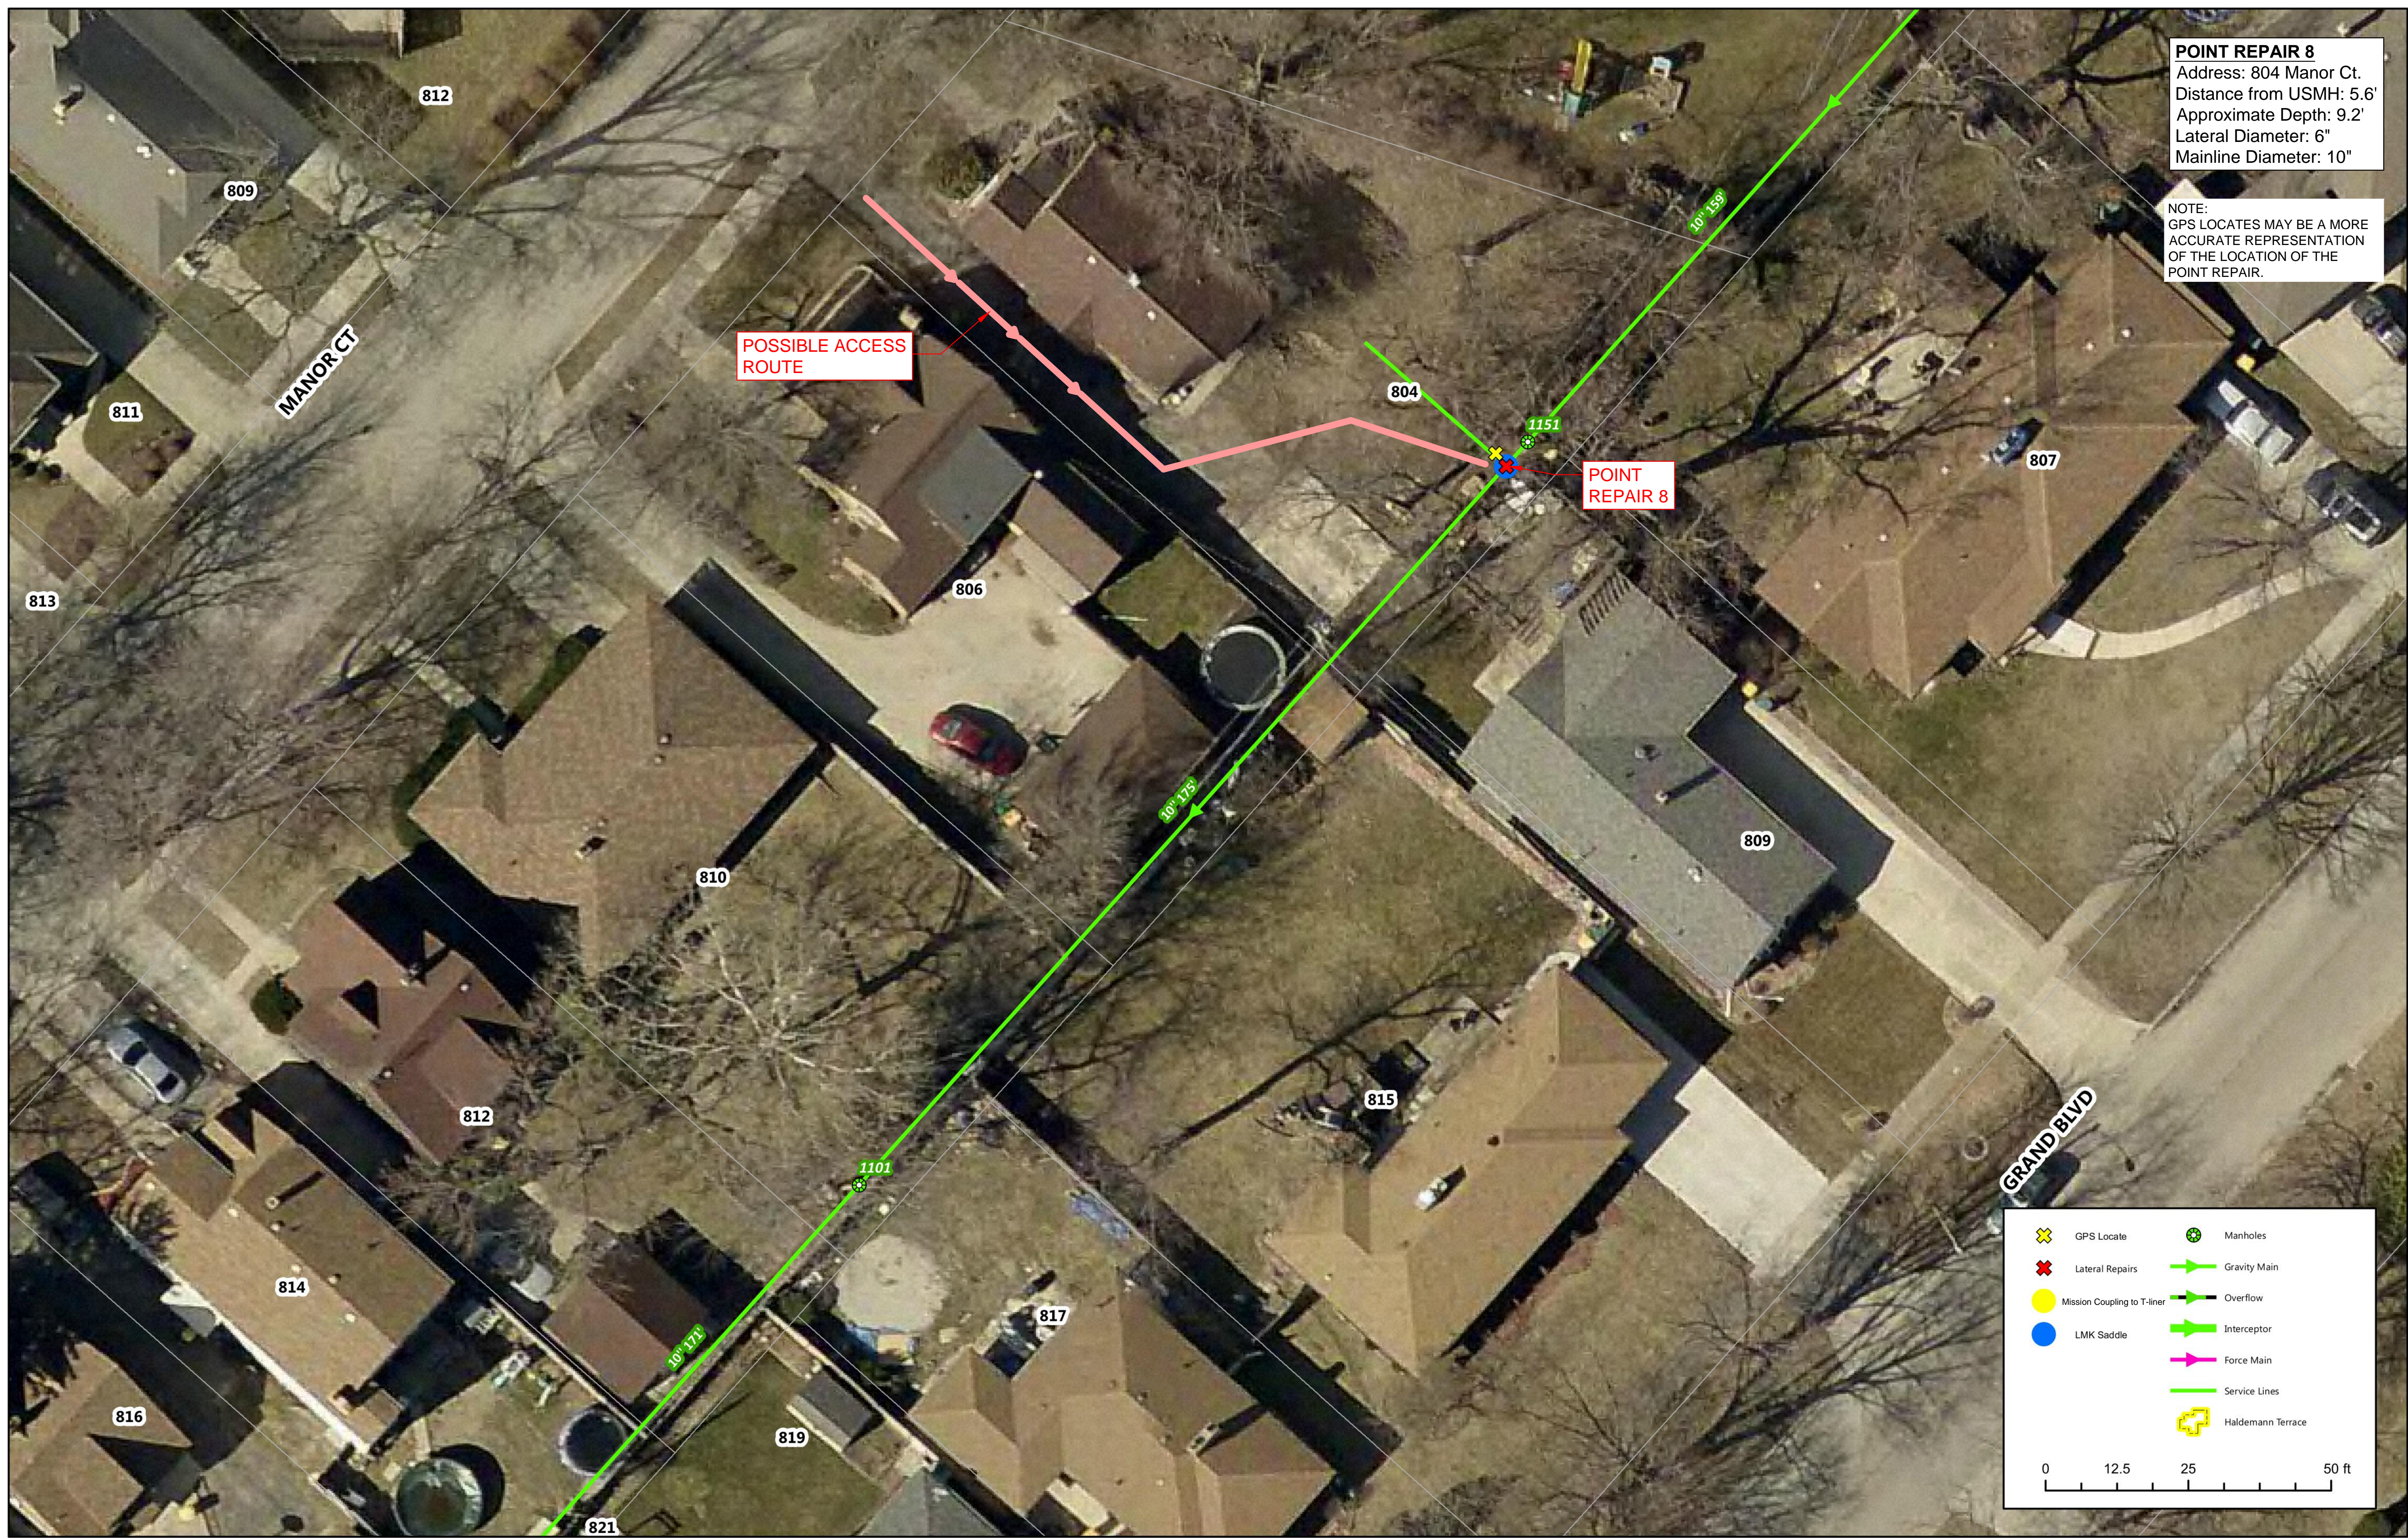
POINT REPAIR 8
 Address: 804 Manor Ct.
 Distance from USMH: 5.6'
 Approximate Depth: 9.2'
 Lateral Diameter: 6"
 Mainline Diameter: 10"

NOTE:
 GPS LOCATES MAY BE A MORE
 ACCURATE REPRESENTATION
 OF THE LOCATION OF THE
 POINT REPAIR.
