CITY OF JOLIET

2016 HALDEMANN TERRACE LATERAL POINT REPAIRS

CONTRACT NO. 2151-0416

INDEX OF SHEETS

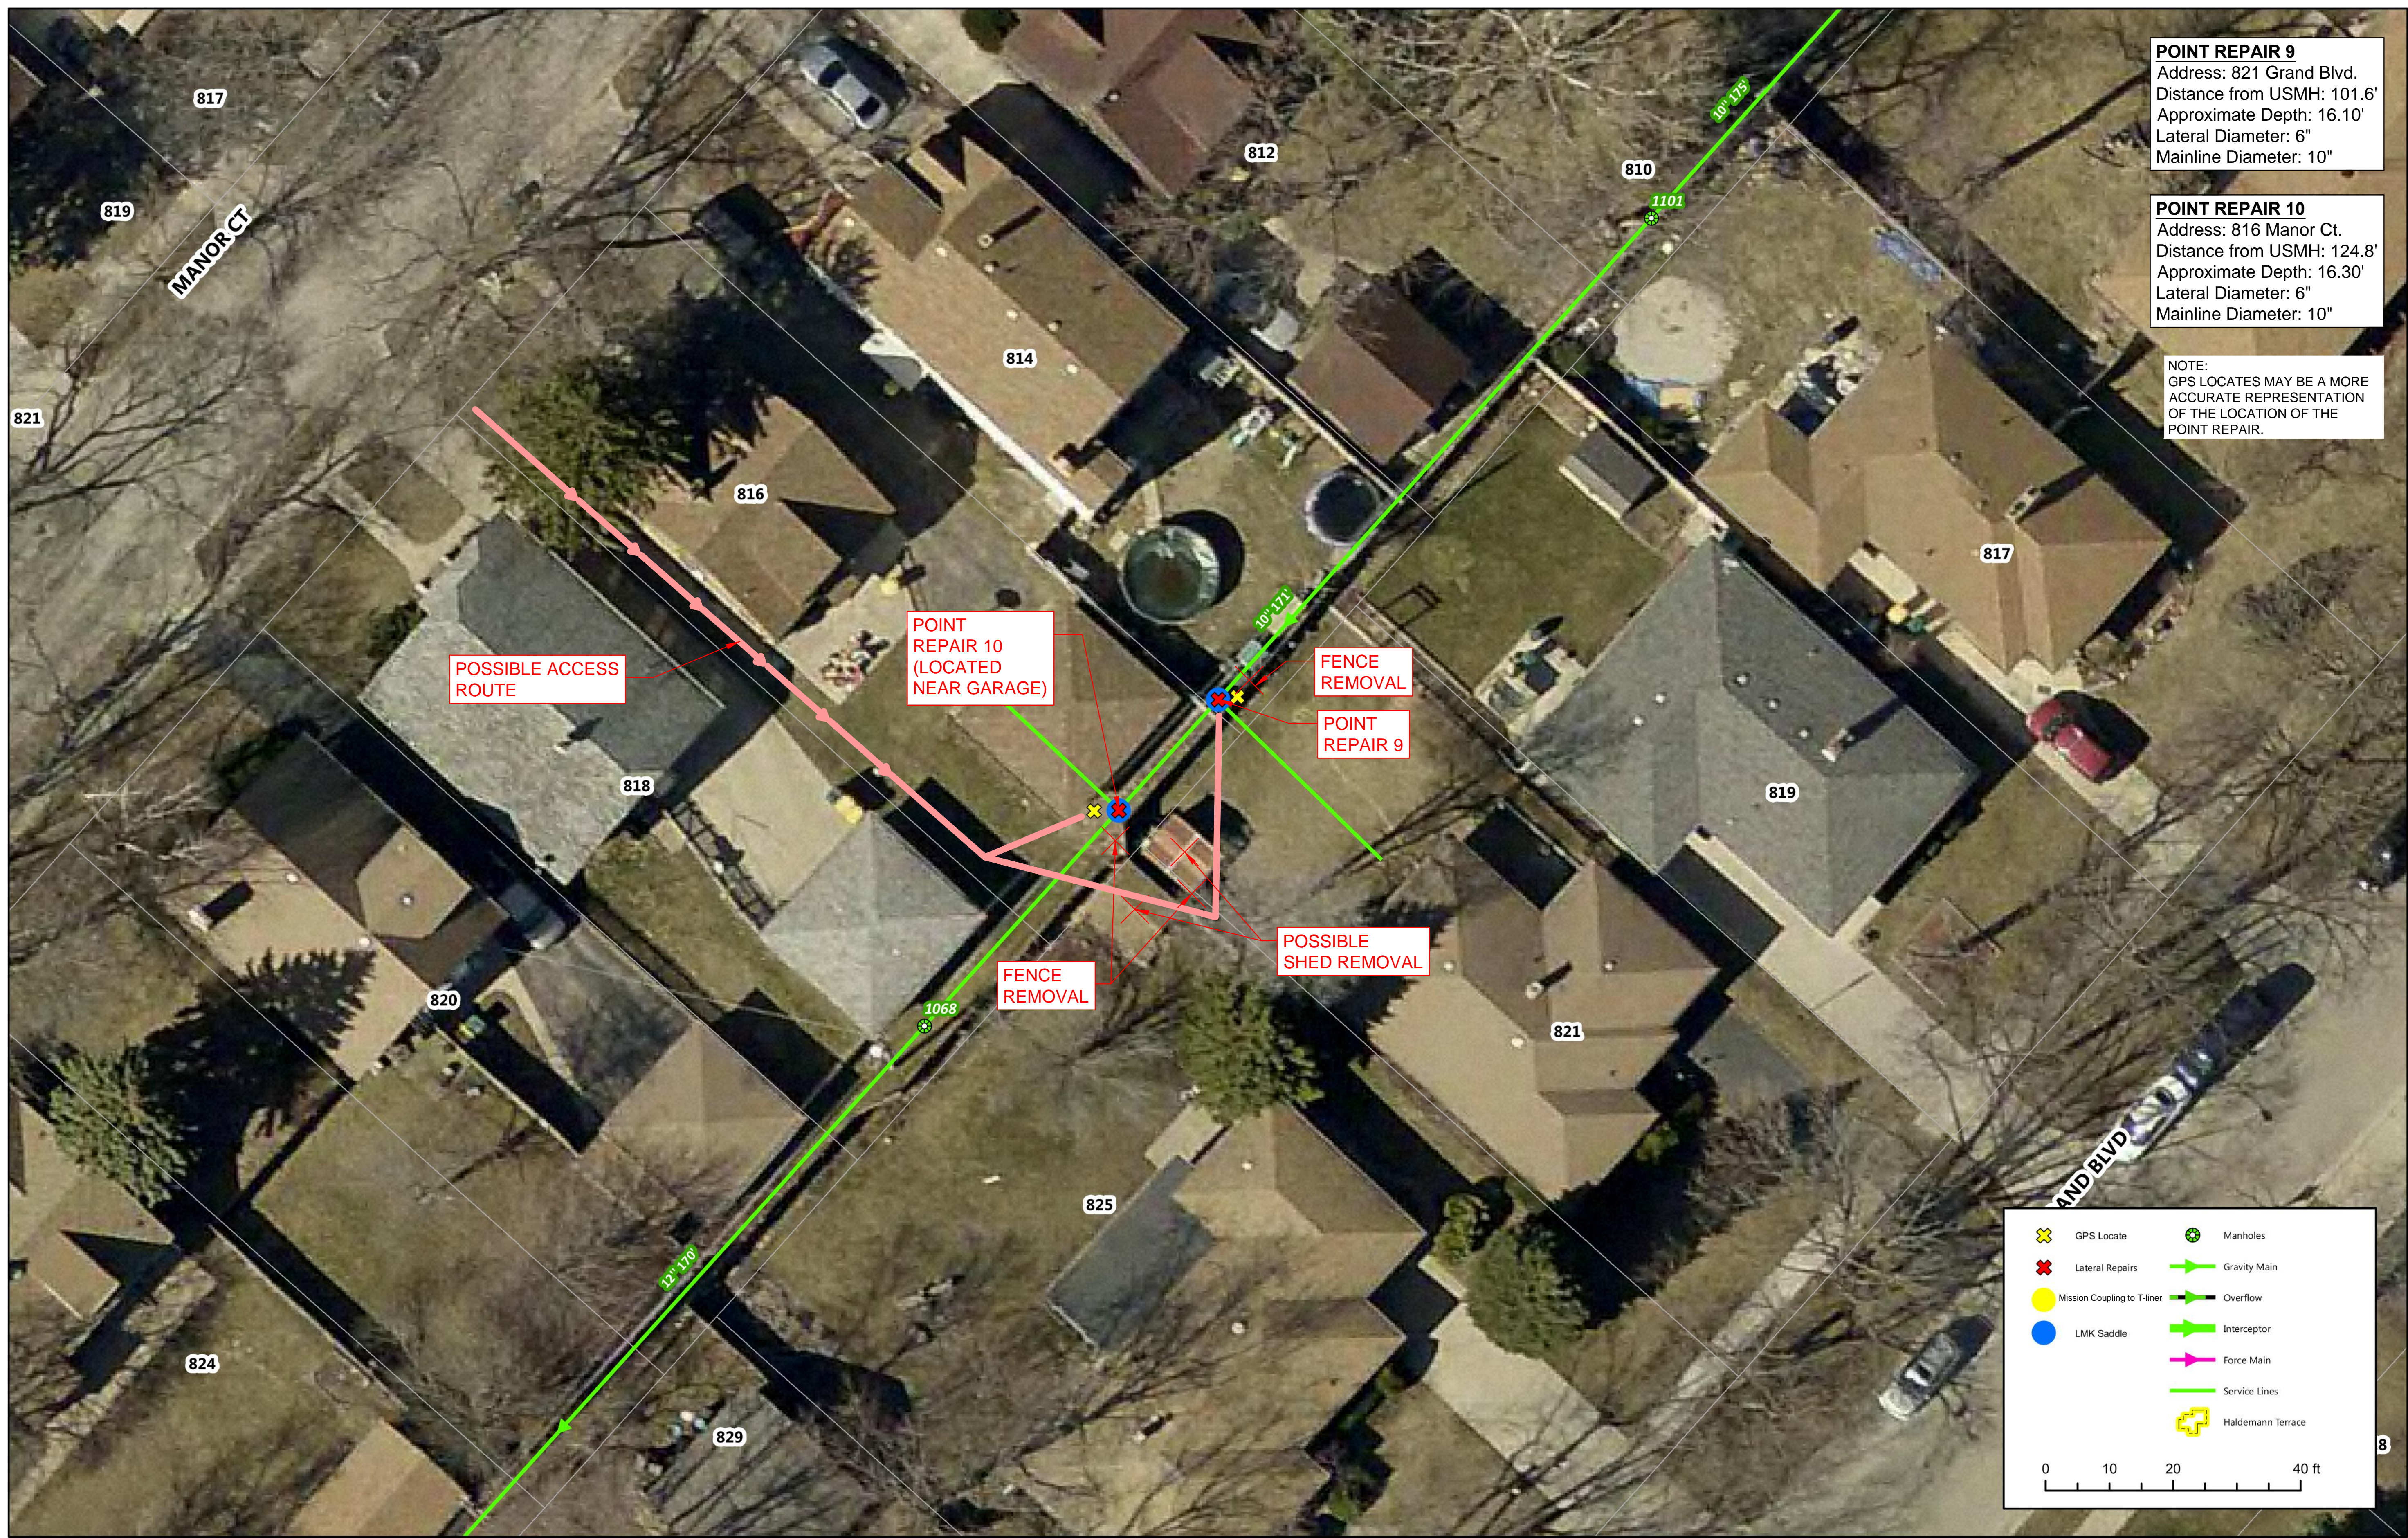
POINT REPAIRS 9 AND 10

POINT REPAIR 9
 Address: 821 Grand Blvd.
 Distance from USMH: 101.6'
 Approximate Depth: 16.10'
 Lateral Diameter: 6"
 Mainline Diameter: 10"

POINT REPAIR 10
 Address: 816 Manor Ct.
 Distance from USMH: 124.8'
 Approximate Depth: 16.30'
 Lateral Diameter: 6"
 Mainline Diameter: 10"

NOTE:
 GPS LOCATES MAY BE A MORE ACCURATE REPRESENTATION OF THE LOCATION OF THE POINT REPAIR.

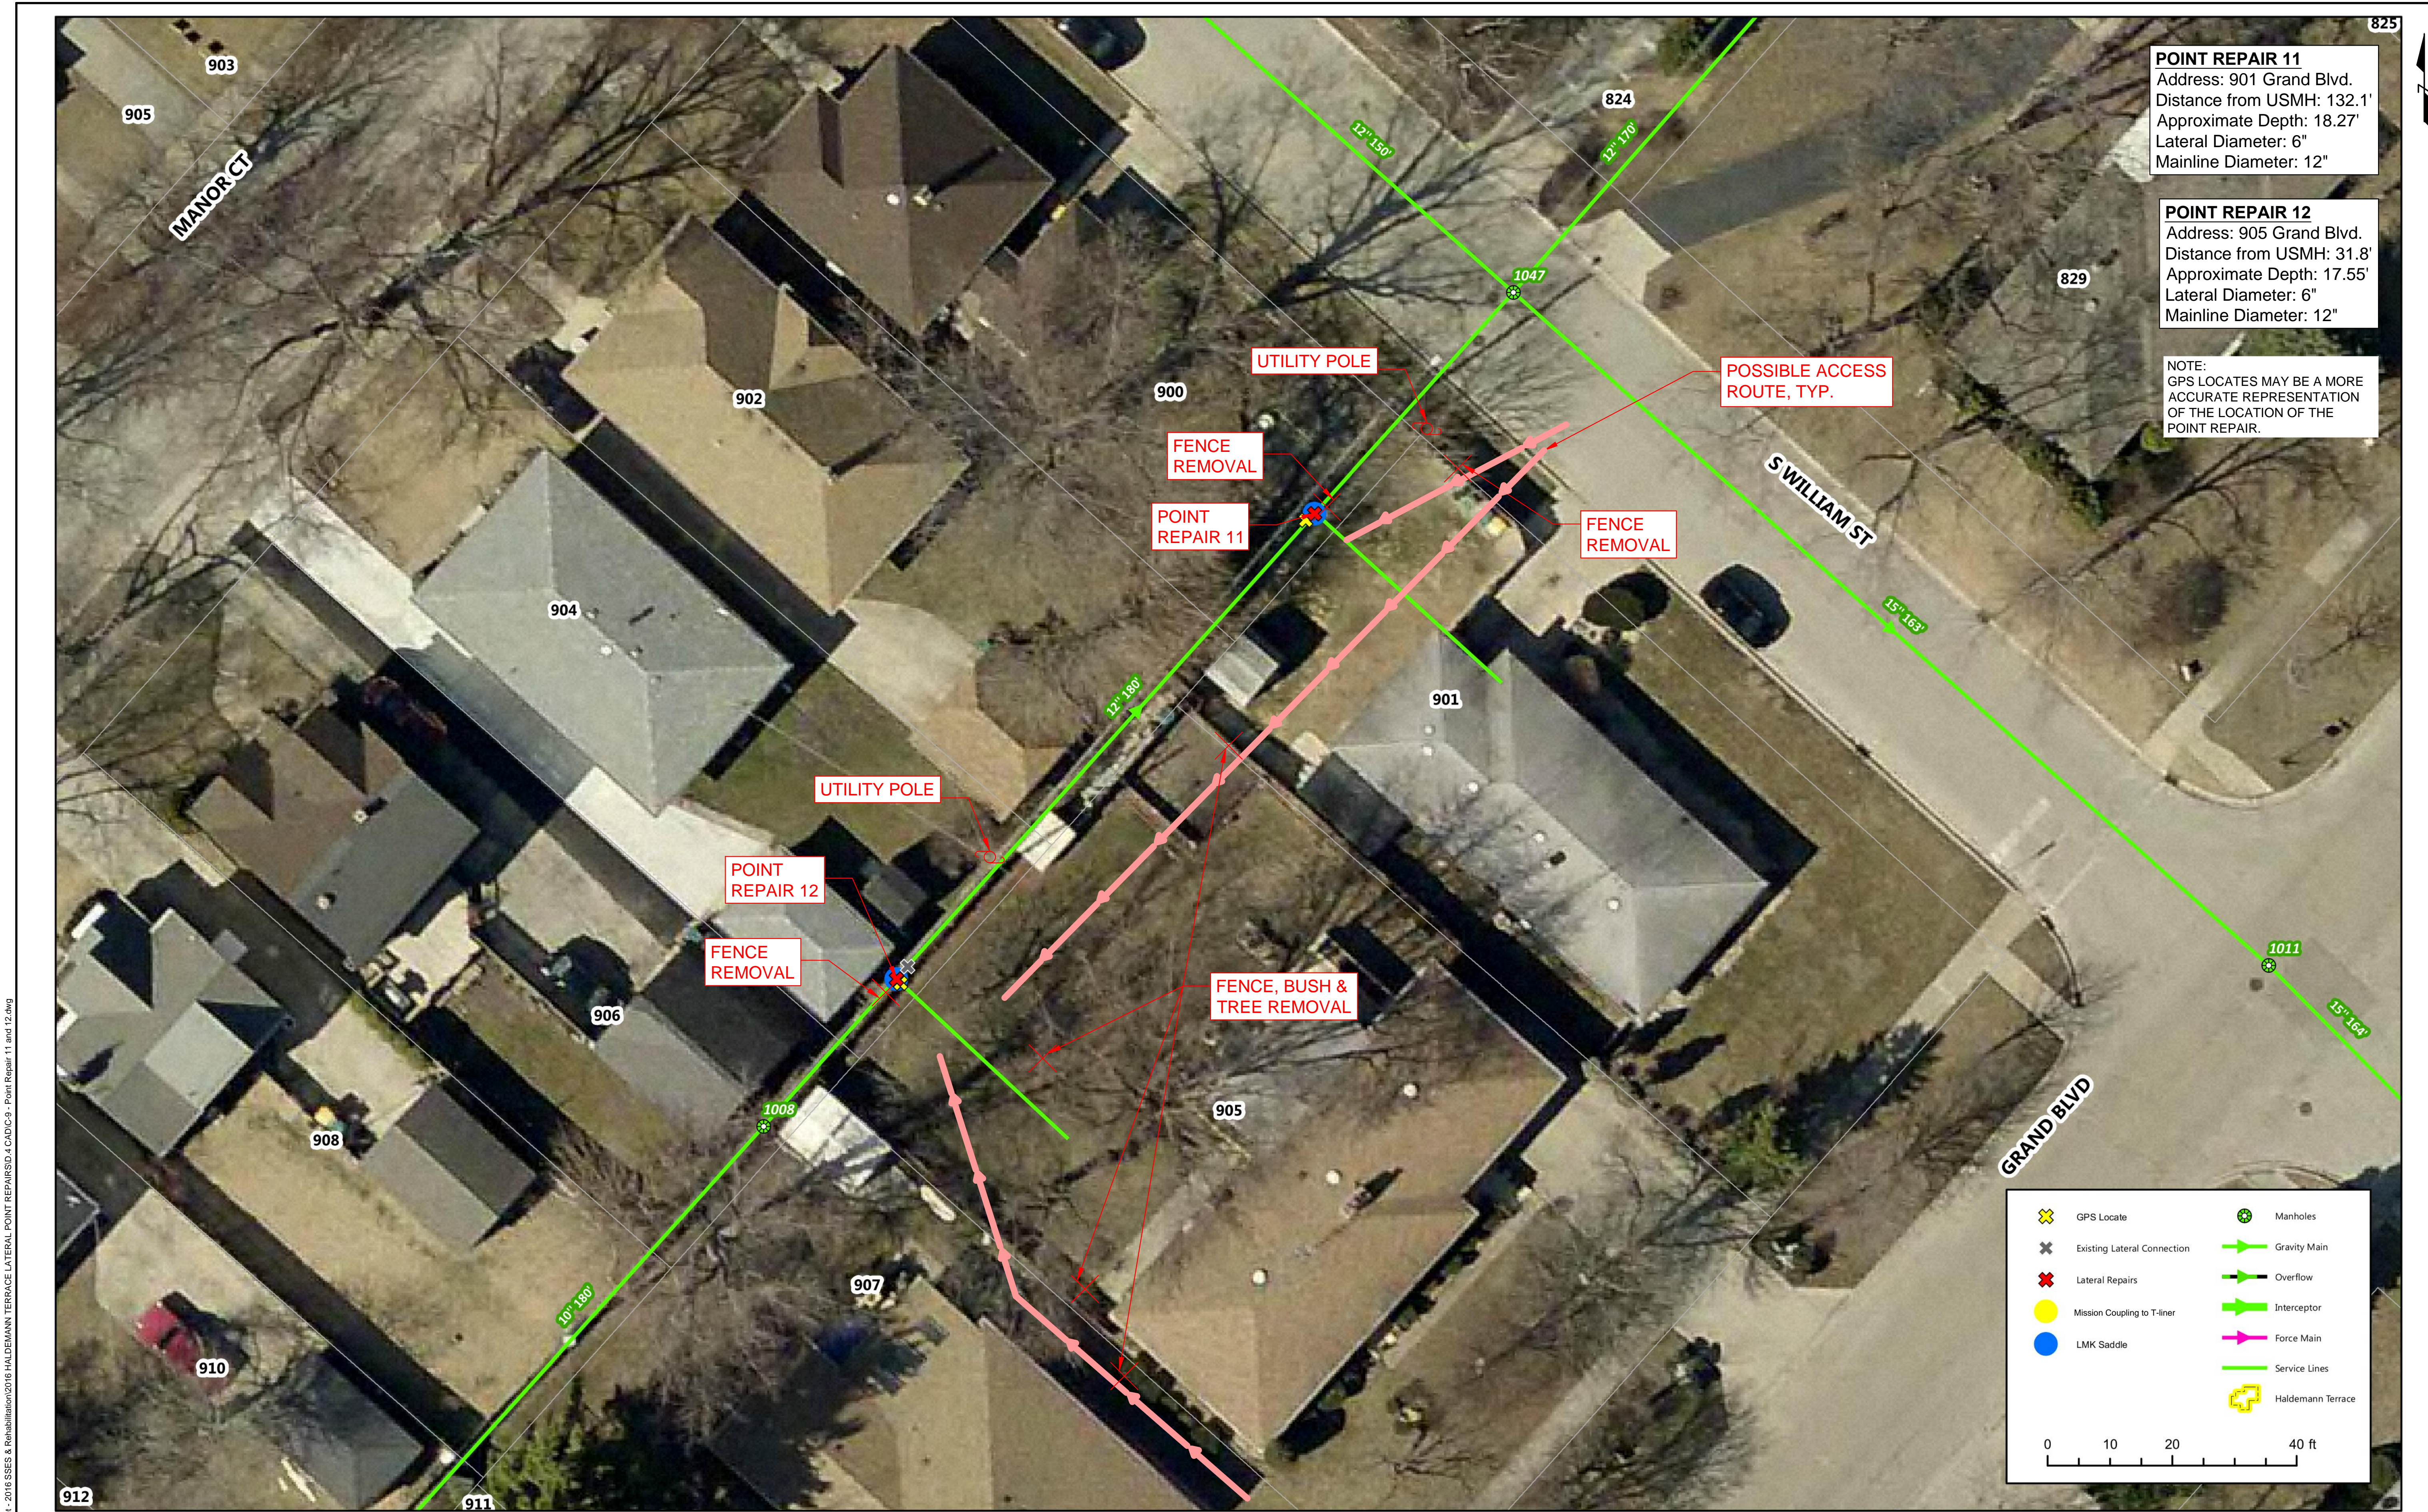
POINT REPAIRS 11 AND 12

POINT REPAIR 11
 Address: 901 Grand Blvd.
 Distance from USMH: 132.1'
 Approximate Depth: 18.27'
 Lateral Diameter: 6"
 Mainline Diameter: 12"

POINT REPAIR 12
 Address: 905 Grand Blvd.
 Distance from USMH: 31.8'
 Approximate Depth: 17.55'
 Lateral Diameter: 6"
 Mainline Diameter: 12"

NOTE:
 GPS LOCATES MAY BE A MORE
 ACCURATE REPRESENTATION
 OF THE LOCATION OF THE
 POINT REPAIR.

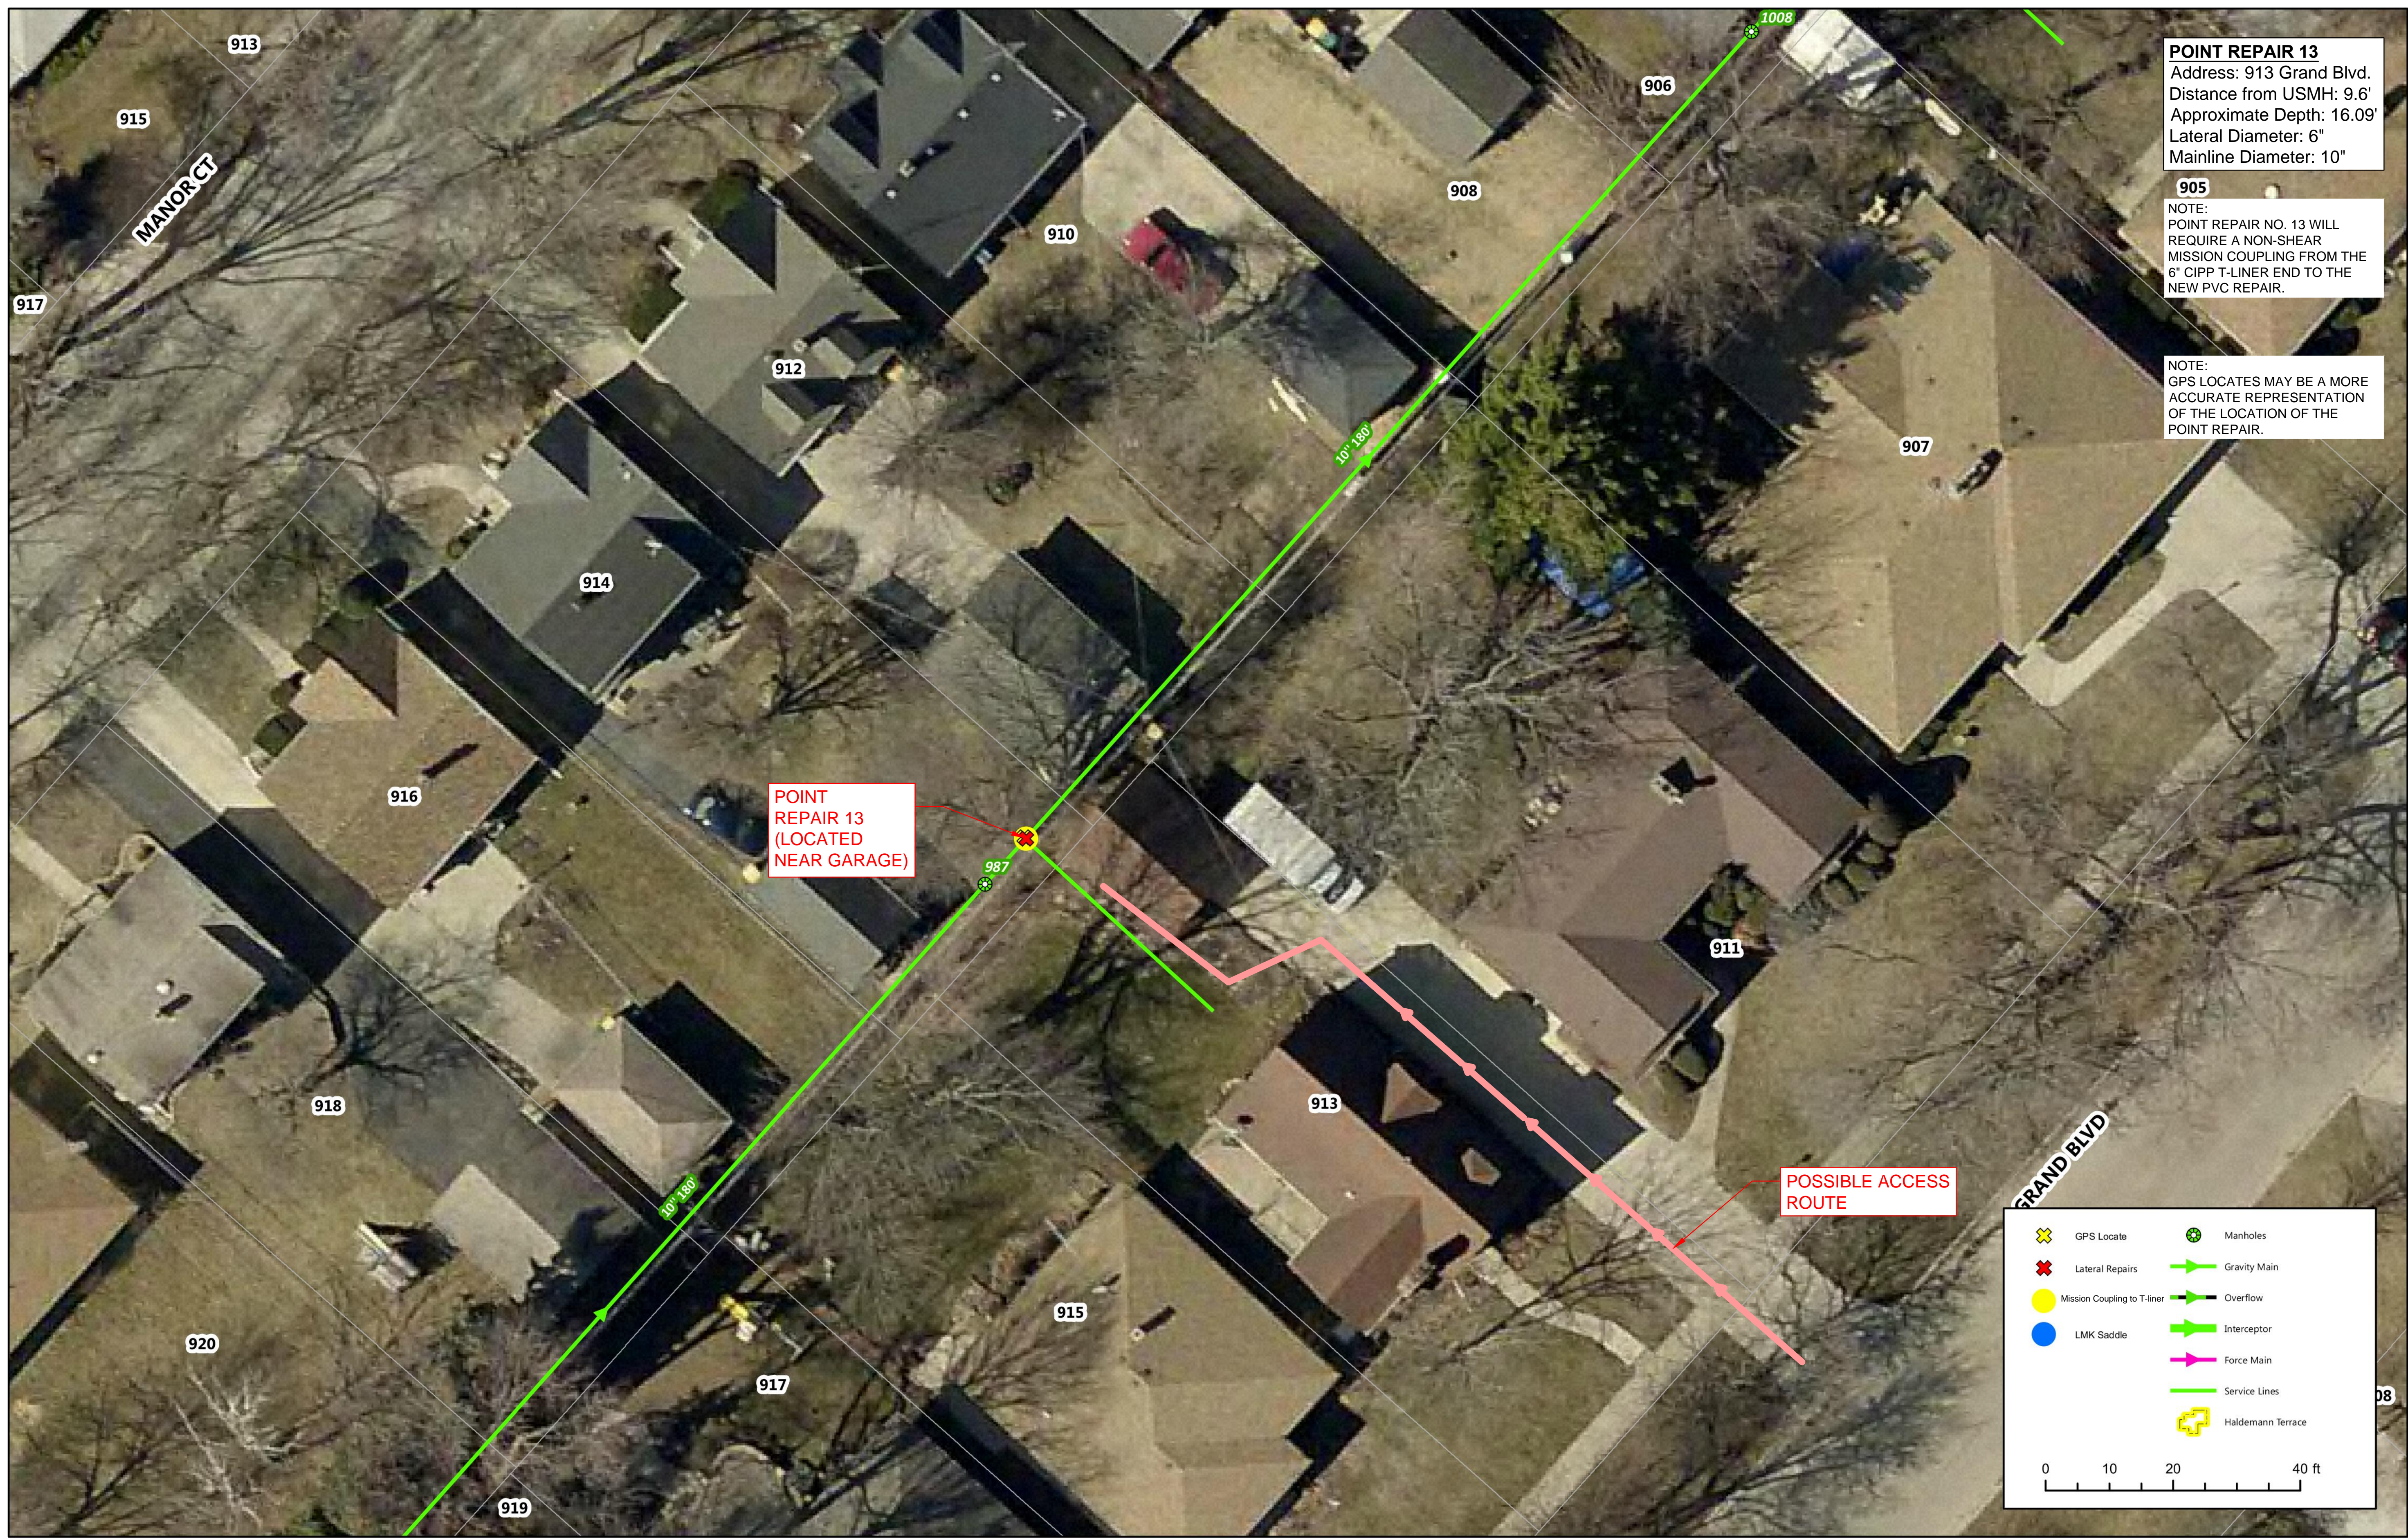
POINT REPAIR 13
 Address: 913 Grand Blvd.
 Distance from USMH: 9.6'
 Approximate Depth: 16.09'
 Lateral Diameter: 6"
 Mainline Diameter: 10"

905
 NOTE:
 POINT REPAIR NO. 13 WILL
 REQUIRE A NON-SHEAR
 MISSION COUPLING FROM THE
 6" CIPP T-LINER END TO THE
 NEW PVC REPAIR.

NOTE:
 GPS LOCATES MAY BE A MORE
 ACCURATE REPRESENTATION
 OF THE LOCATION OF THE
 POINT REPAIR.

**POINT
 REPAIR 13
 (LOCATED
 NEAR GARAGE)**

Note:
- Point Repair No. 13 will require a non-shear mission coupling from the 6" CIPP T-liner end to the new PVC repair.

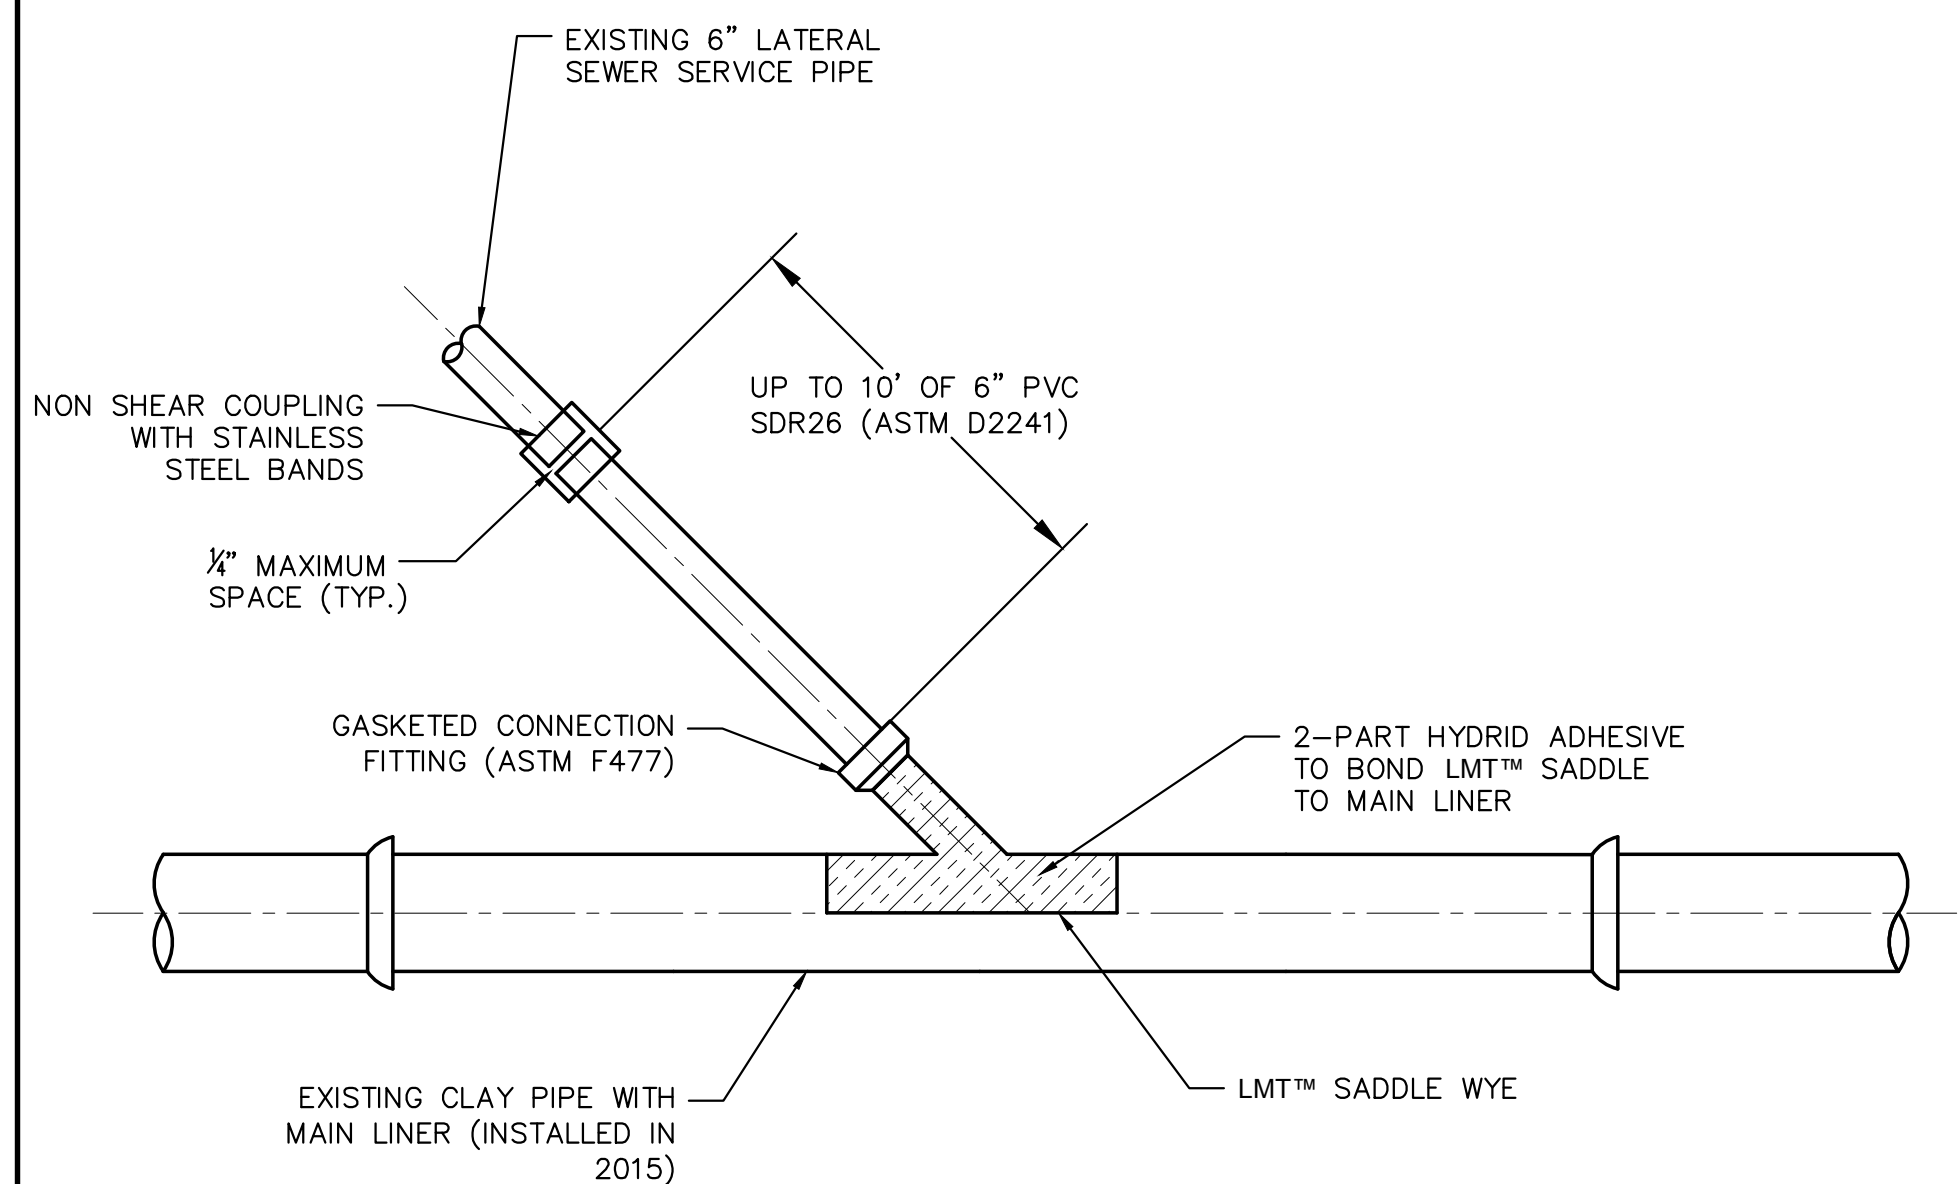
CONNECTION OF SEWER LATERAL TO EXISTING MAINLINE WITH LMT™ WYE
N.T.S.

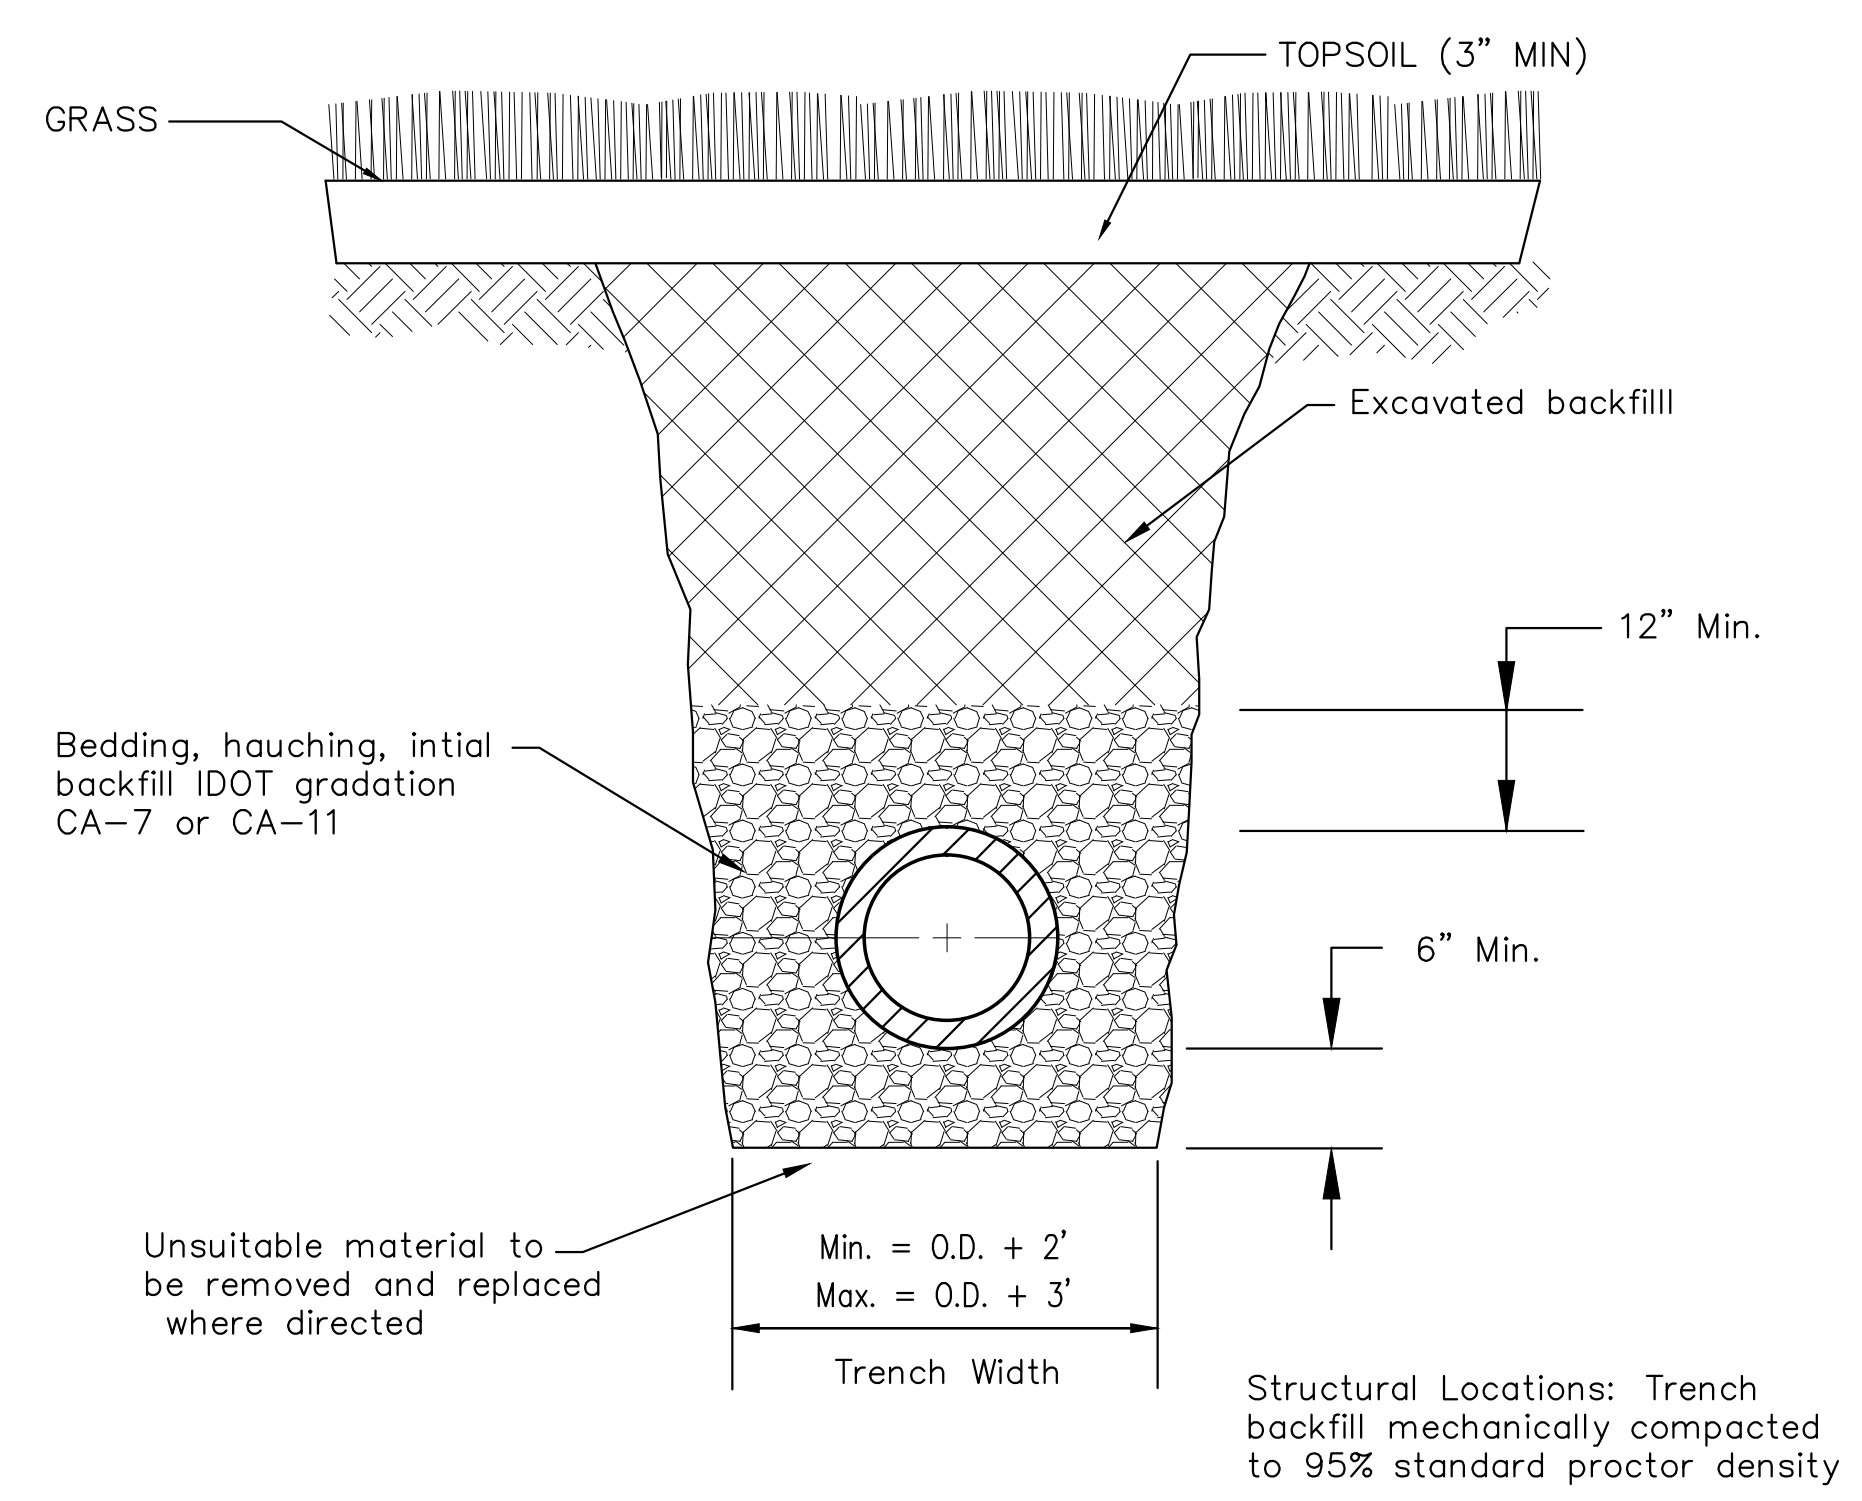
UTILITY TRENCH IN NON-PAVED AREAS
N.T.S.

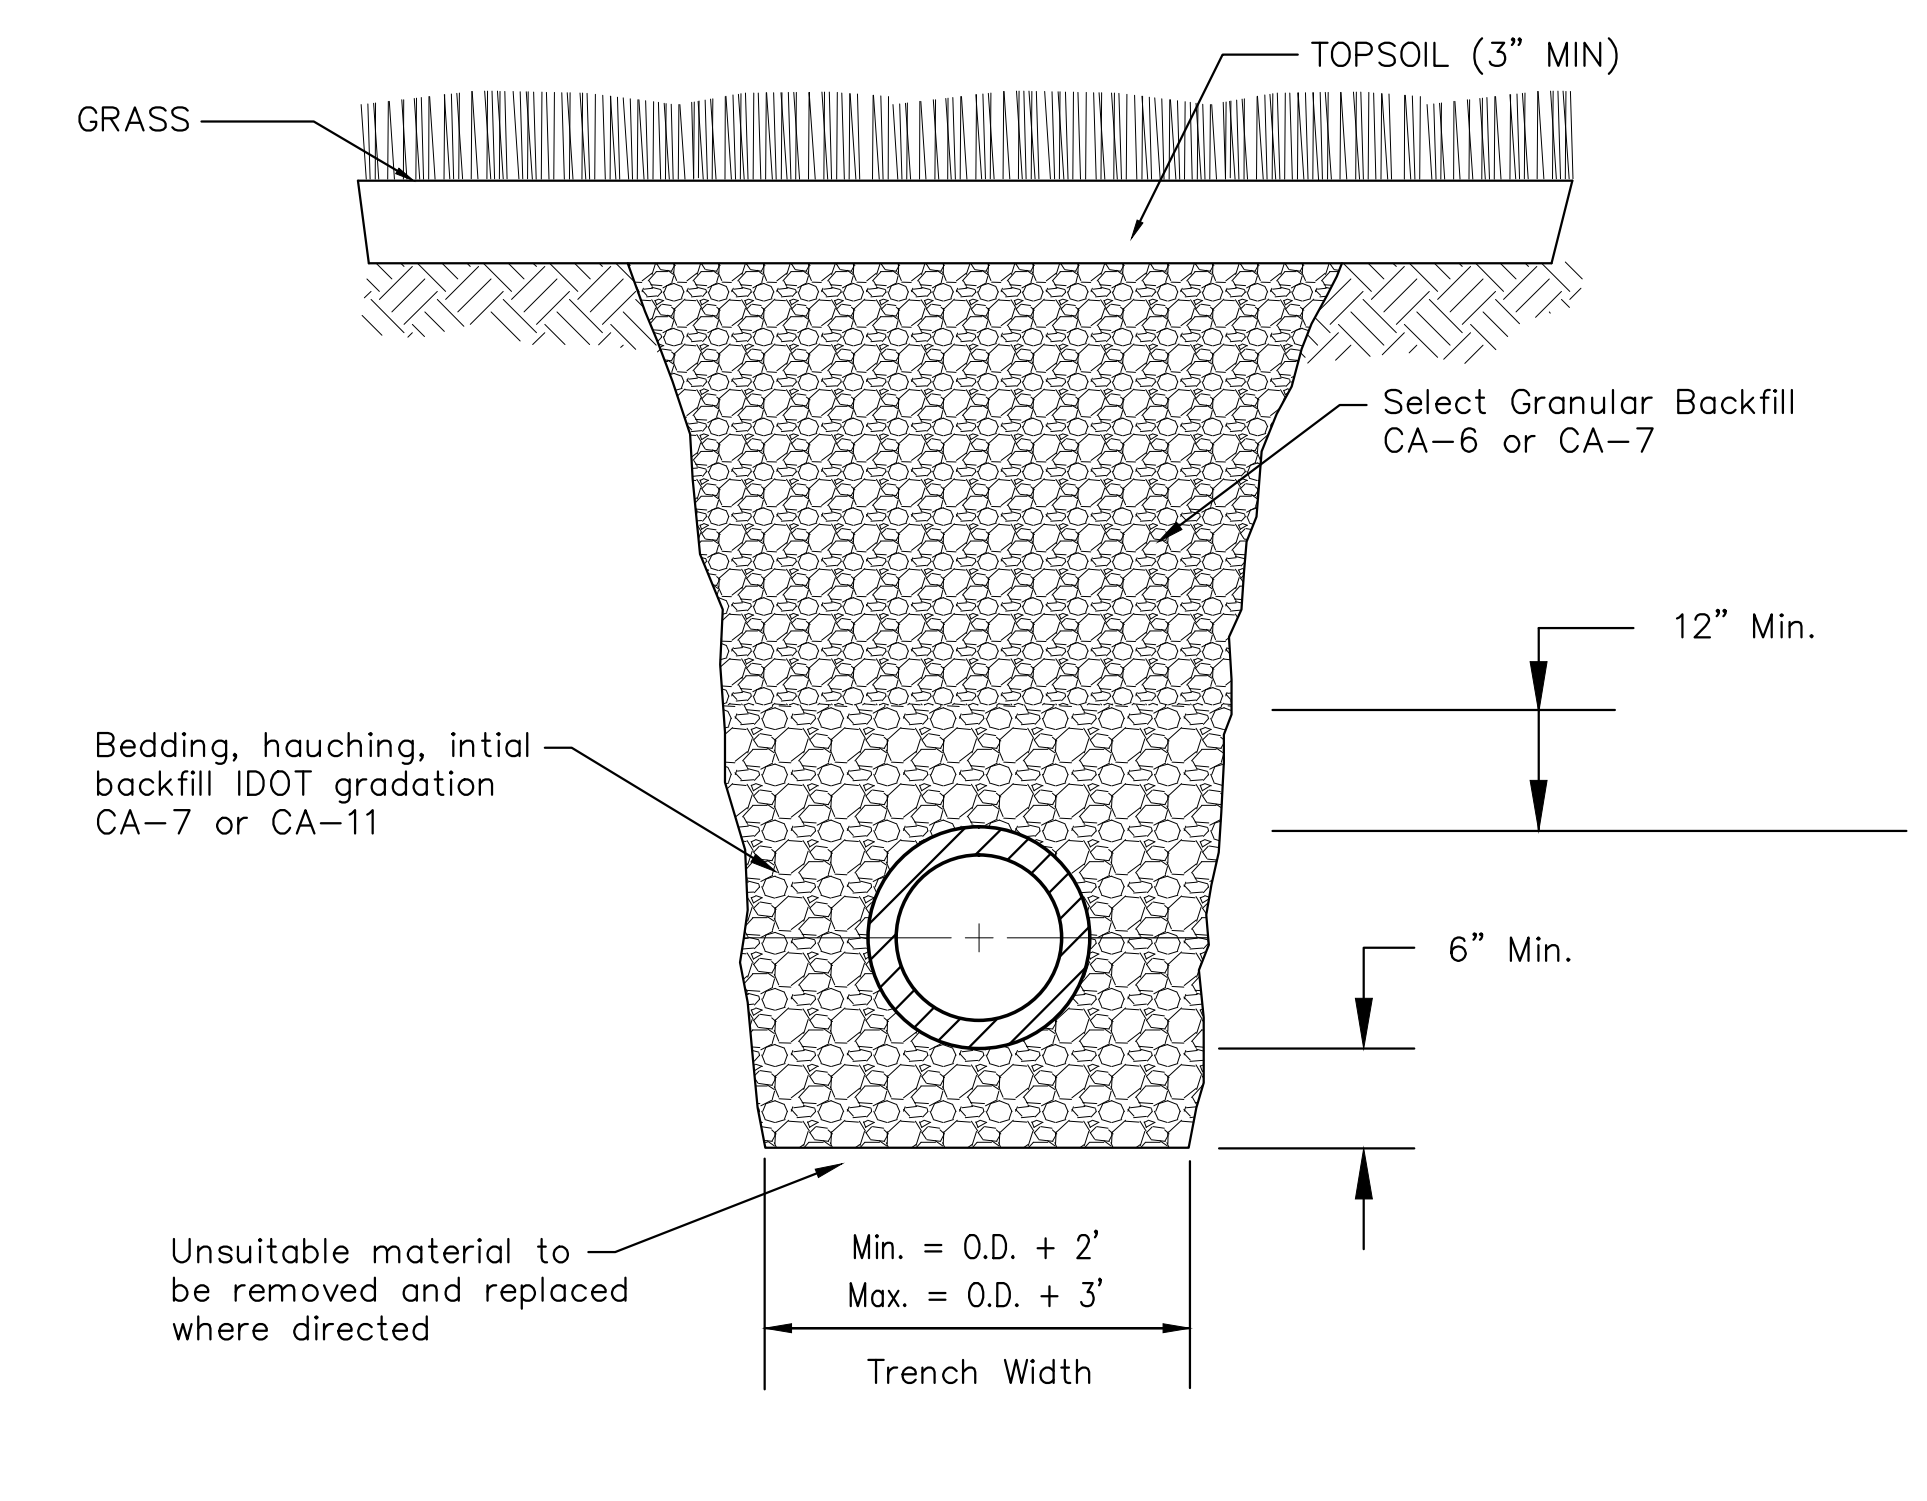
UTILITY TRENCH WITHIN 5' OF AN EXISTING GARAGE FOUNDATION
N.T.S.

- Trenches within 5' of garages are to be backfilled with trench backfill which shall be crushed stone, gradation CA-7 or CA-6.
- Fence restoration shall occur within 24 hours of removal. If point repair is not completed within 24 hours, the contractor shall coordinate with the engineer and install temporary fencing if requested by the homeowner.

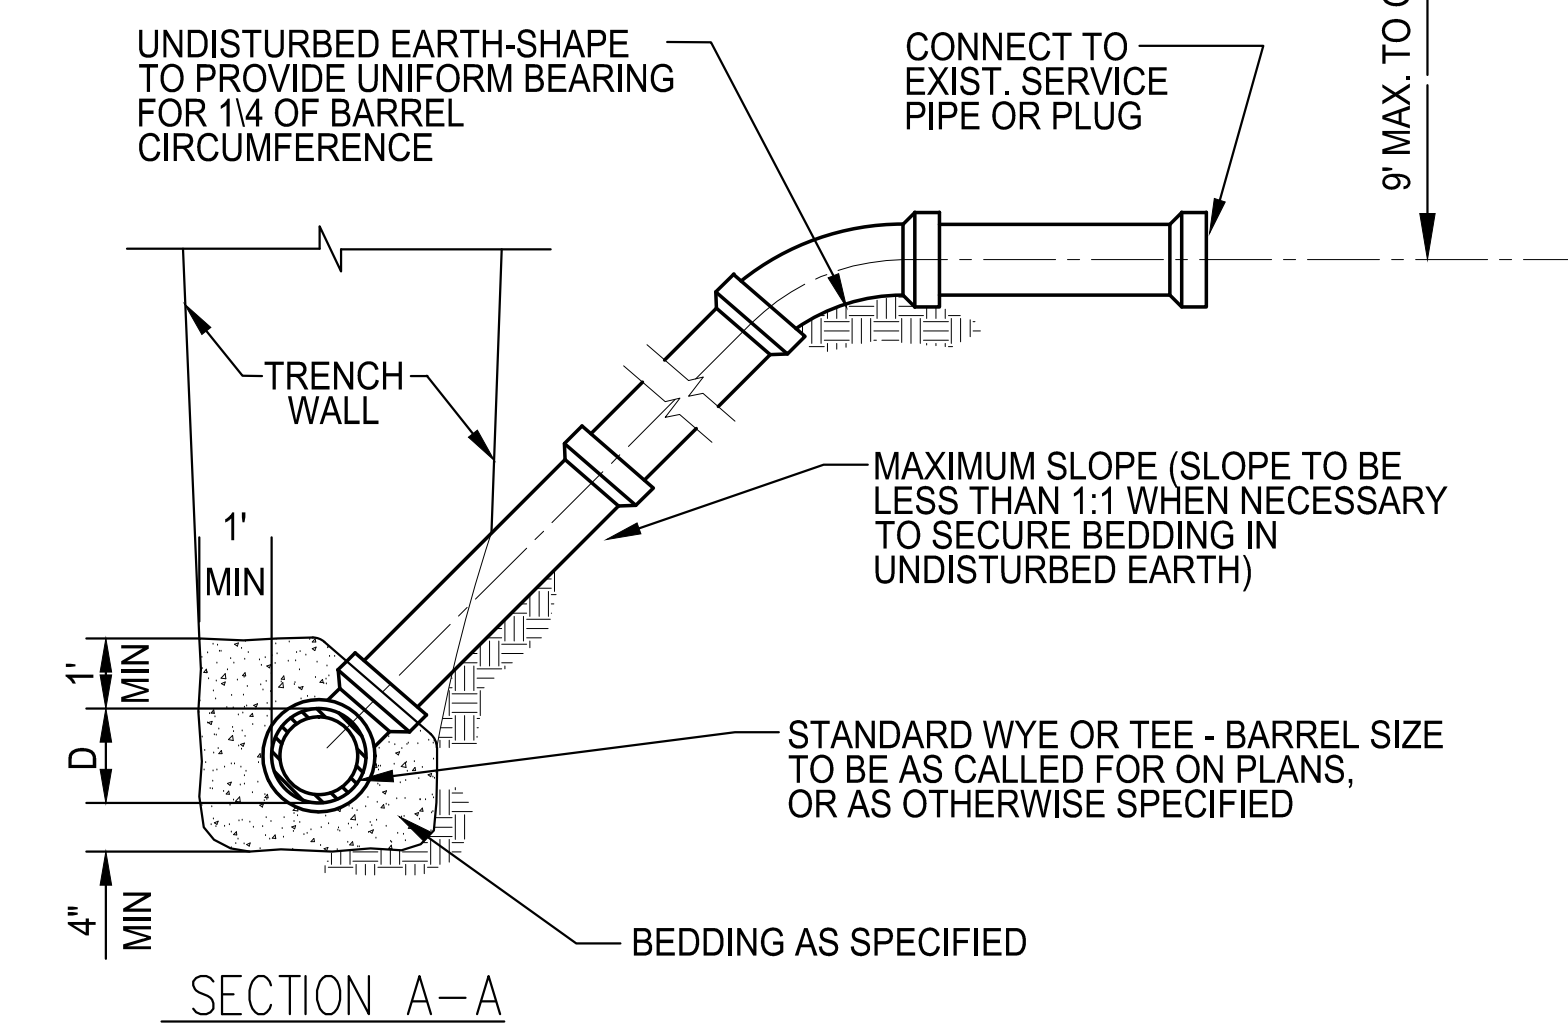
TYPICAL RISER SANITARY SERVICE LATERAL
N.T.S.

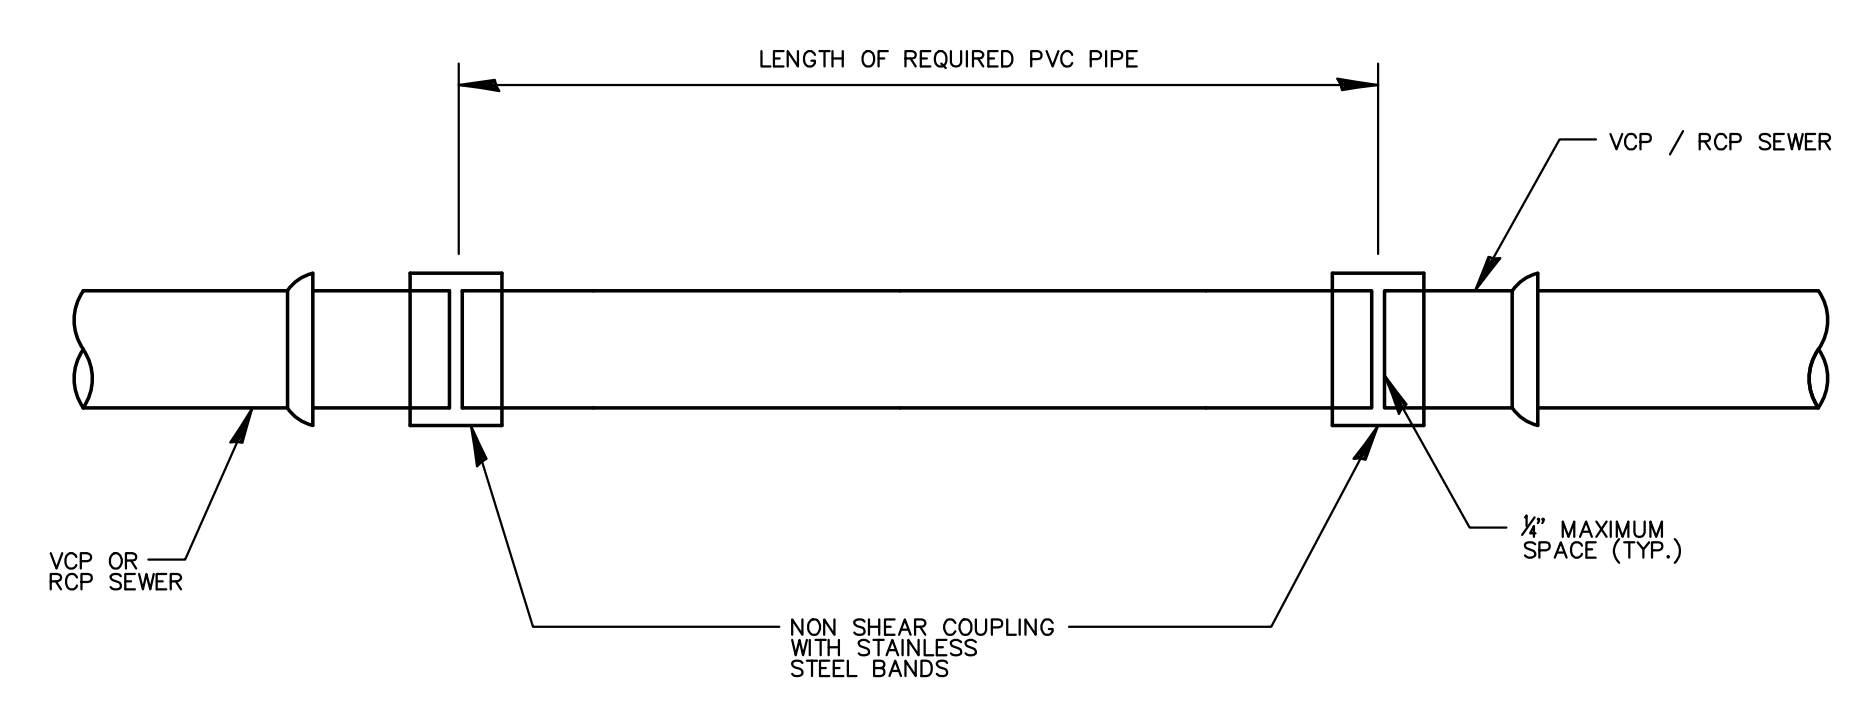
CONNECTING SEWER PIPES OF SIMILAR & DISSIMILAR MATERIAL
N.T.S.

- "Band Seal" or similar flexible type coupling shall be used at all points of change in sanitary sewer pipe material.
- When connecting to the existing sanitary sewer, if no wye, tee or manhole is existing, one of the following methods shall be used:
