CITY OF JOLIET

2016 HALDEMANN TERRACE LATERAL POINT REPAIRS

CONTRACT NO. 2151-0416

INDEX OF SHEETS

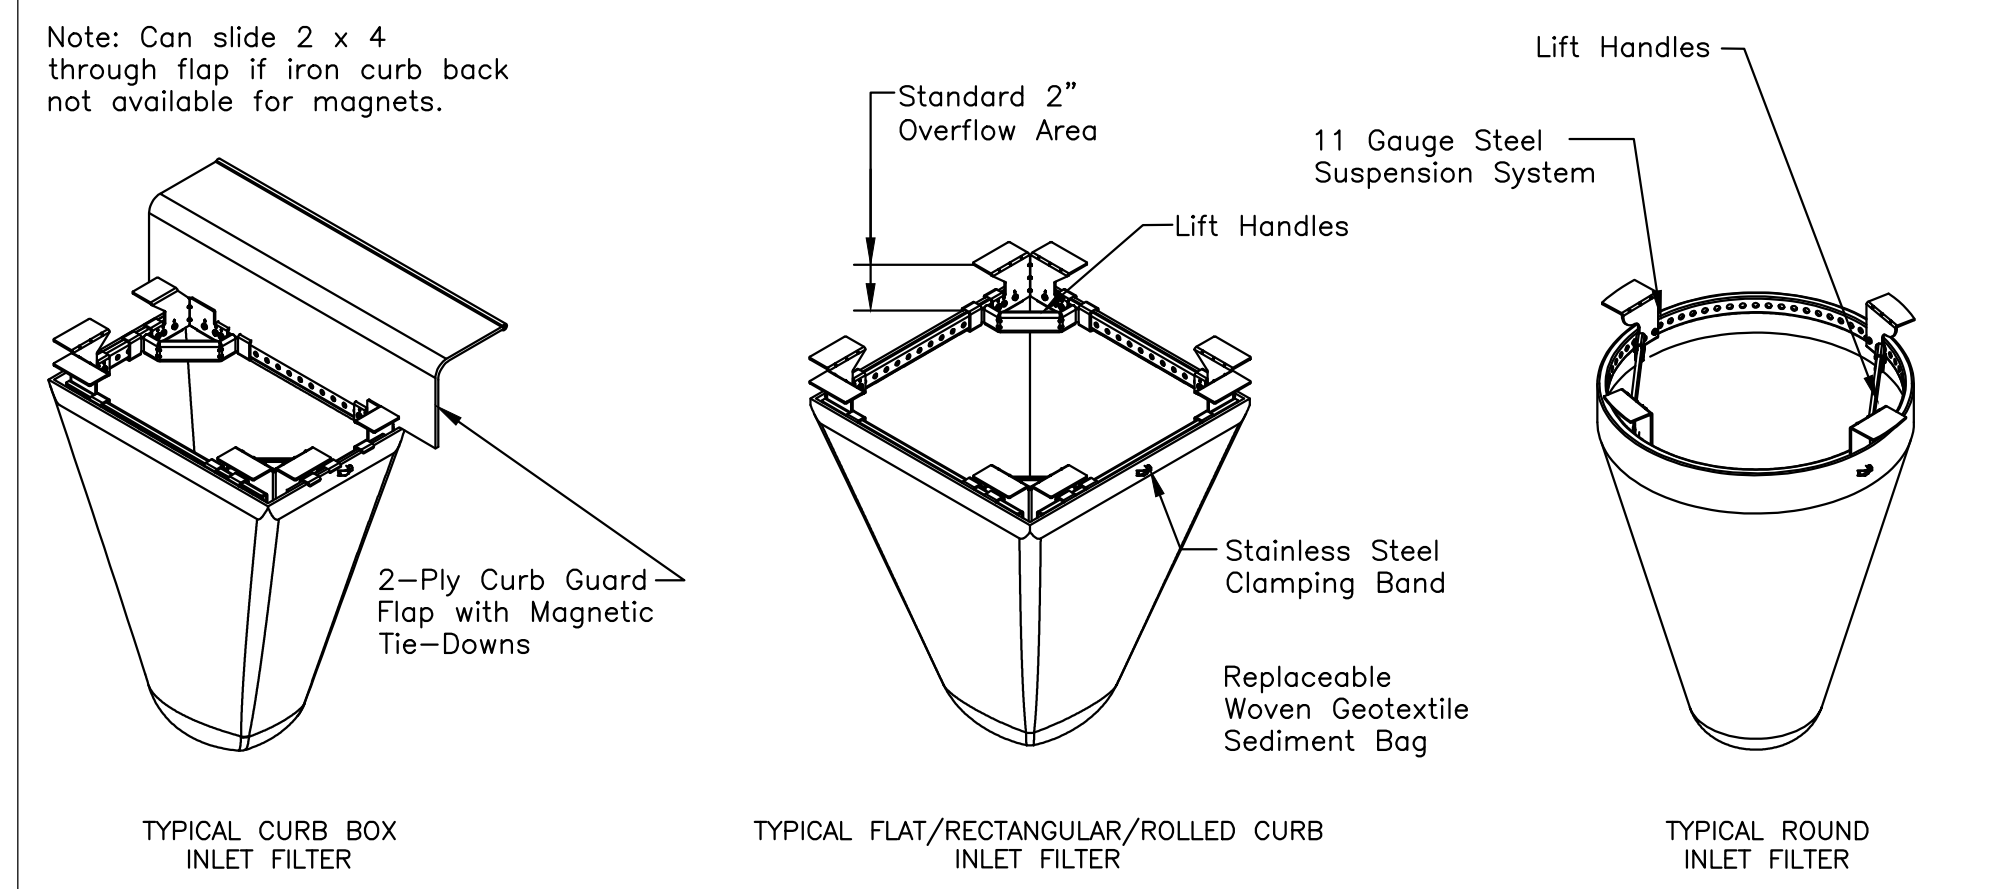
- Materials:**
1. Framing - 11 gauge steel; corrosion resistant
 2. Sediment Bag - Woven Geotextile (Type FF or approved alternate); 2 cubic ft typ volume; Stainless Steel locking band securing bag to frame
- Installation:**
1. Remove grate
 2. Drop Inlet Filter onto load bearing lip of casting or concrete structure
 3. Replace grate

STORM DRAIN INLET PROTECTION
N.T.S.
